# 'ENGINEERING' CONSERVATION

## CAMPUS MLC NORTH SYDNEY

## MLC, North Sydney

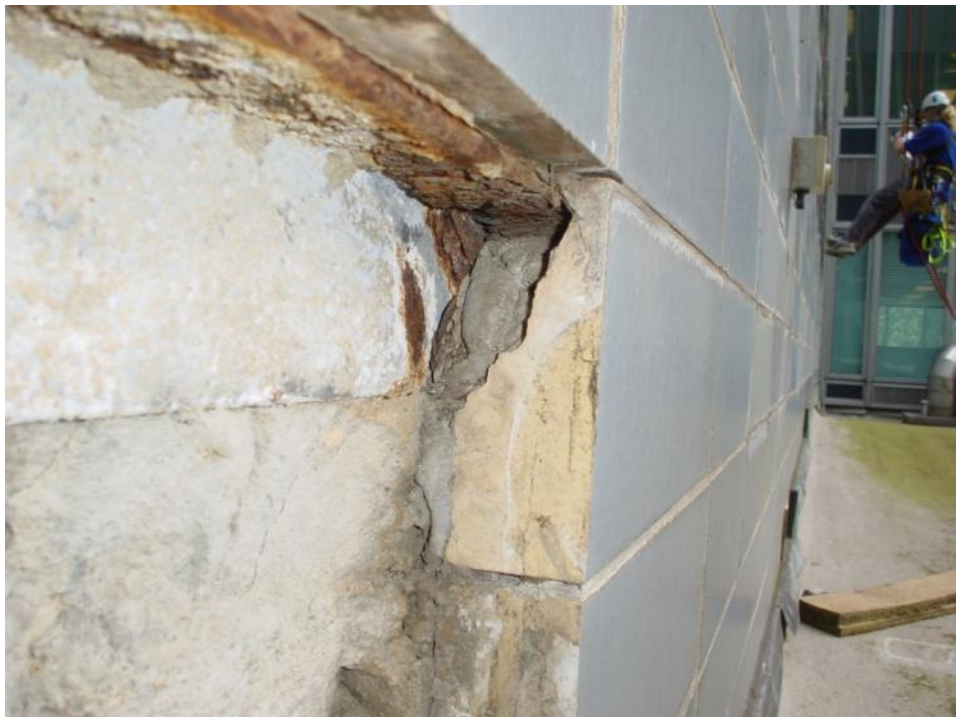
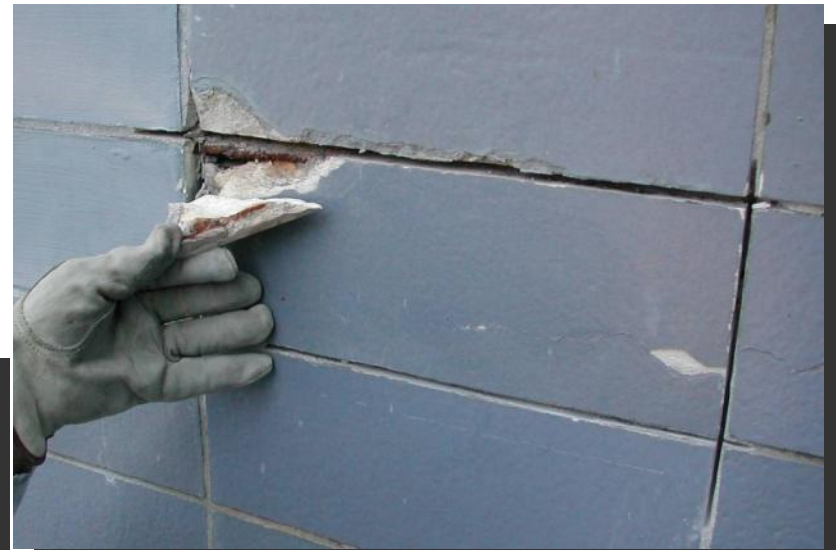
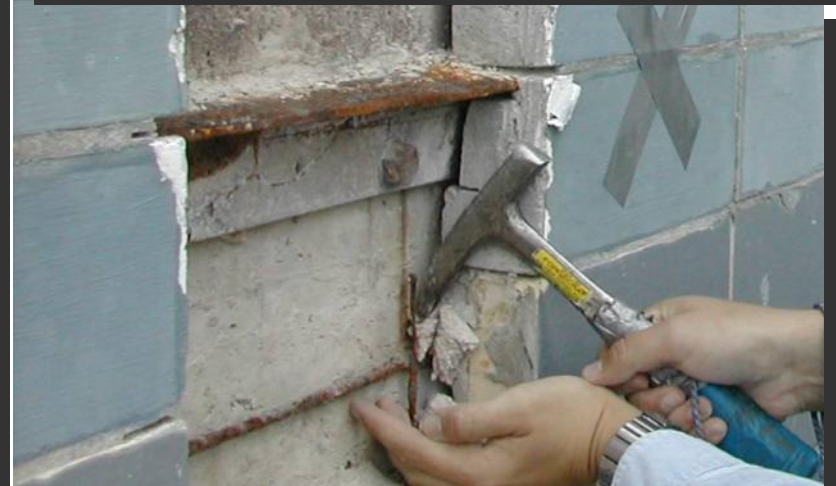
## Deterioration – Shelf Angles

- Shelf angles corroding on leading edge

- Cut out and replace with stainless steel
- Insert movement joints at shelf angle locations
- New shelf angles where required for dead load support

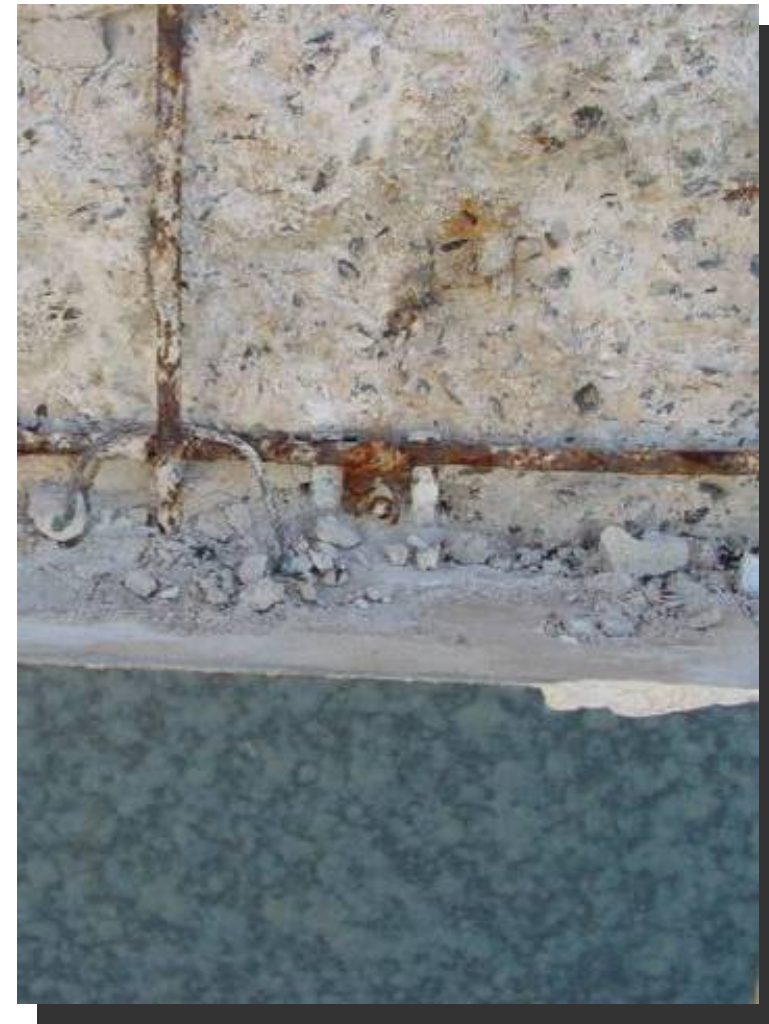
- Corrosion of mesh
- Corrosion of shot-fired fixing clips
- Reinforcing mesh corroded completely in places

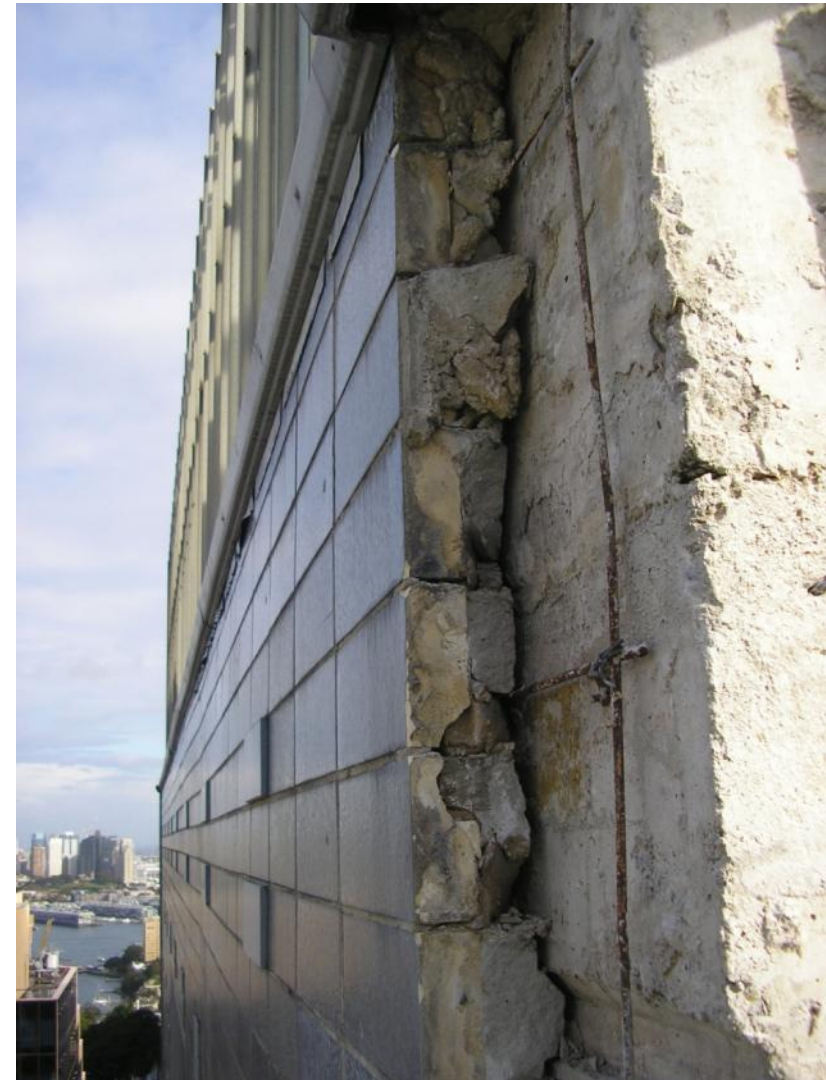
## Deterioration – Detachment of Terracotta

- Extensive areas of drummy terracotta
- Opening up indicated debonding between mortar backfill and concrete
- Potential to detach in large sections

- Helifix ties @ 500mm centres

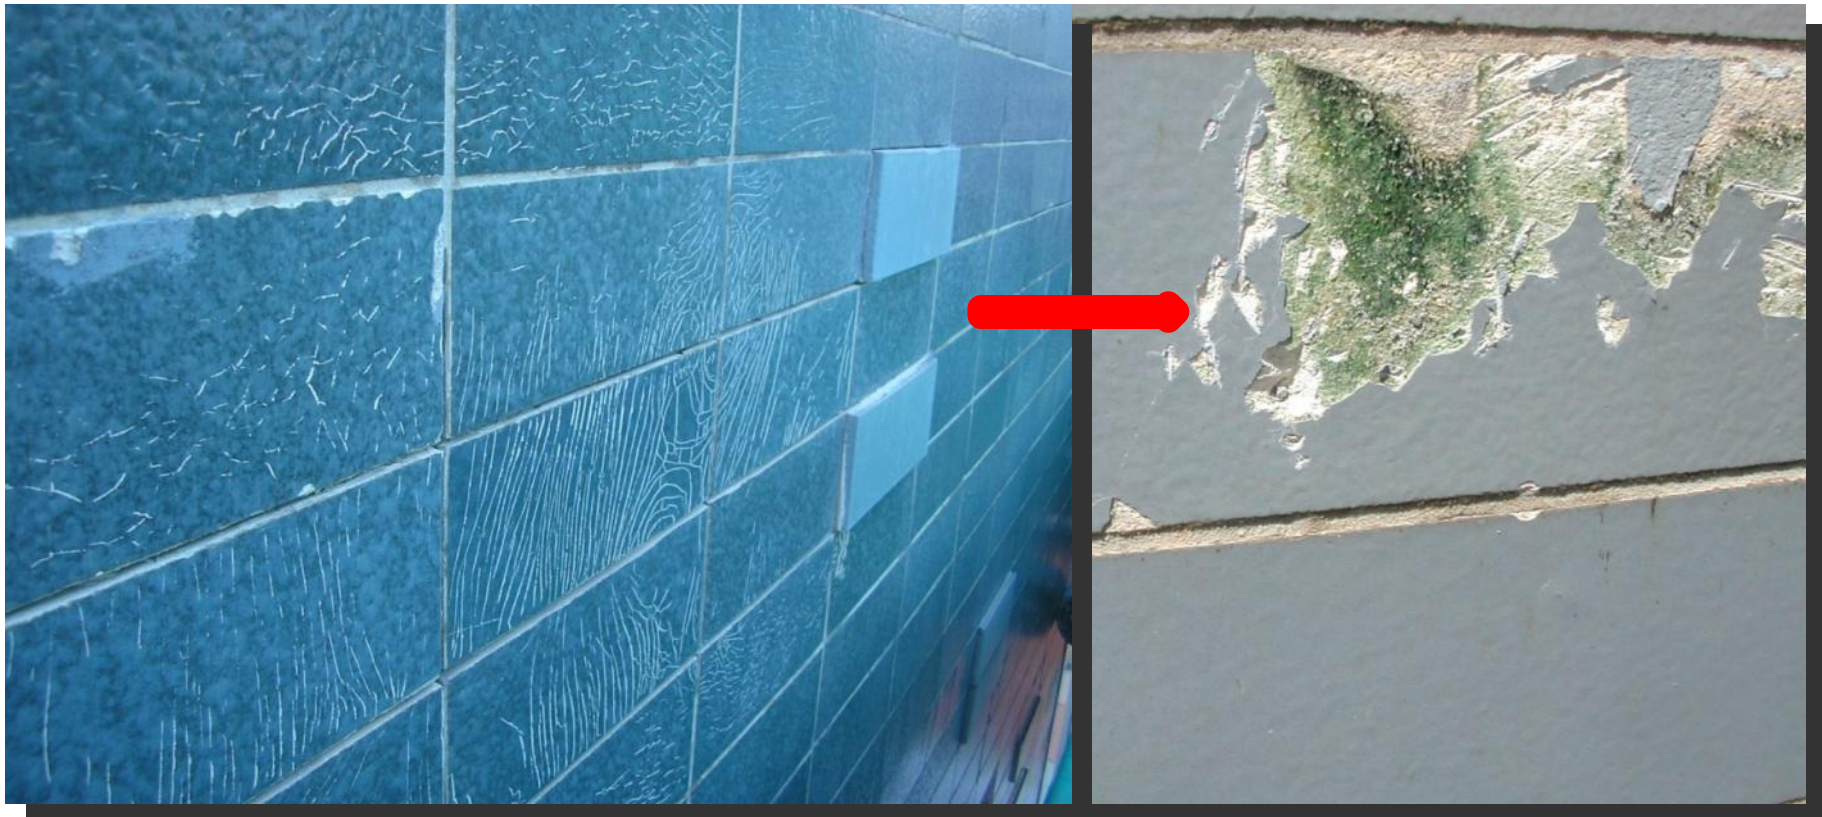
## Deterioration – Glaze

- Glaze crazing and spalling
- Movement / crystallisation of soluble salts

- Address water ingress
- Replace units with >50% glaze spalled
- Patch and coat with proprietary products (Edison Coatings, USA)

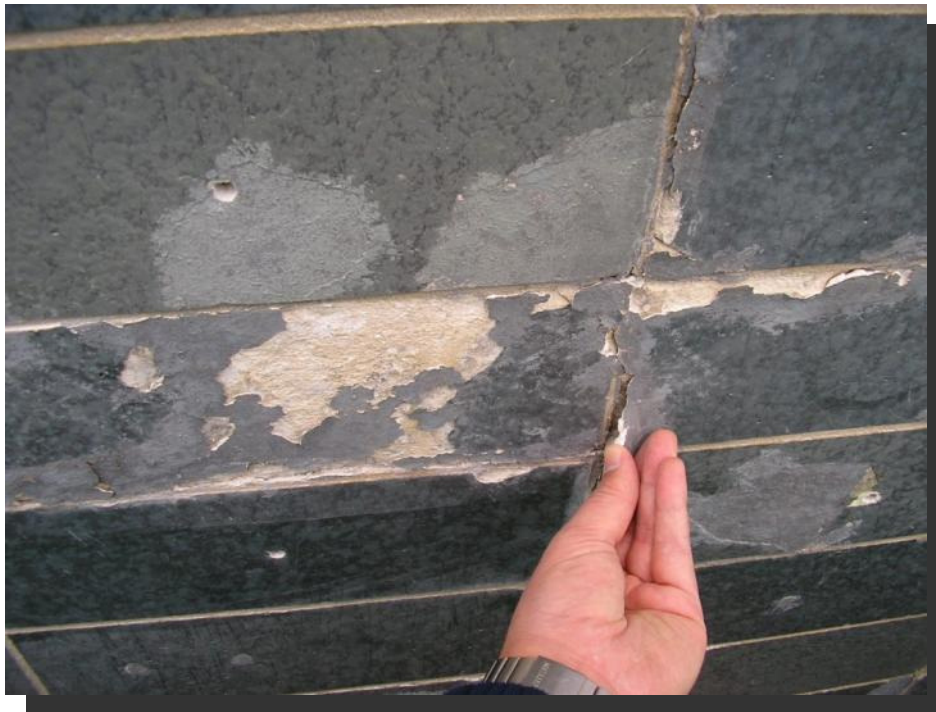
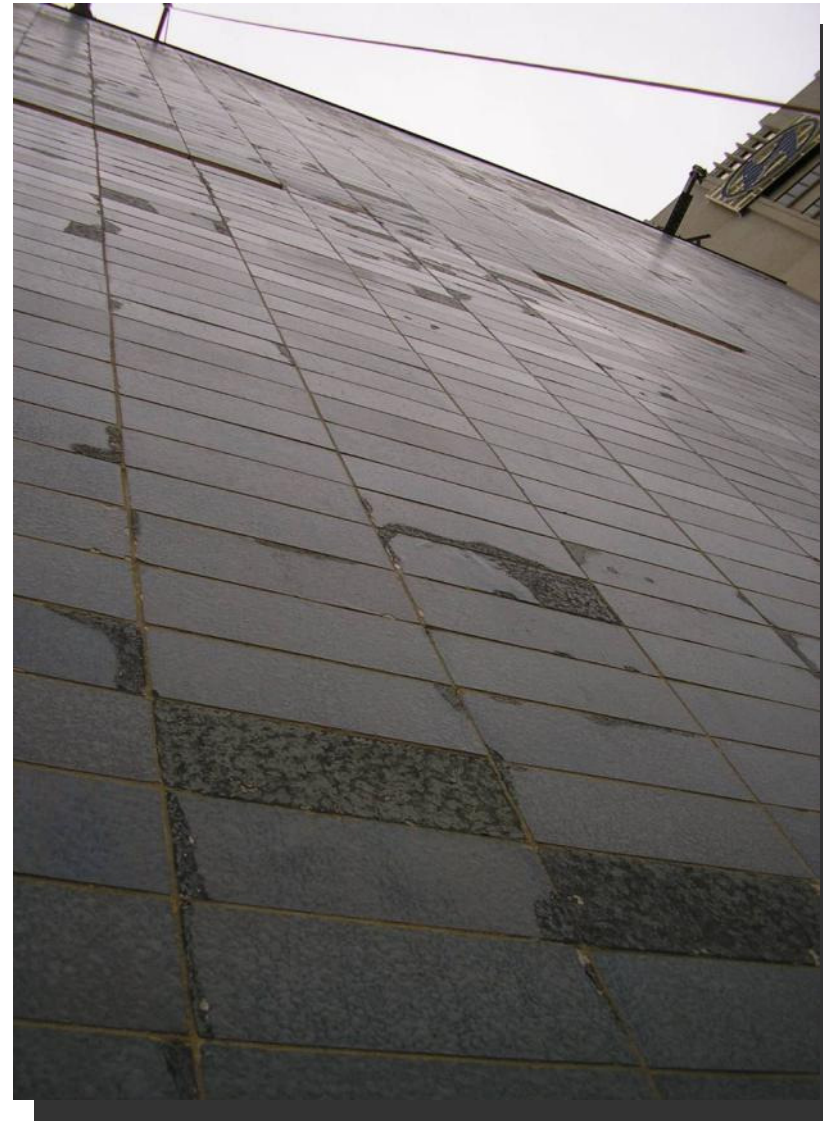
## Past Repairs – Lessons

- Cementitious replacement units - painted
- Patching and inpainting of glaze spalls

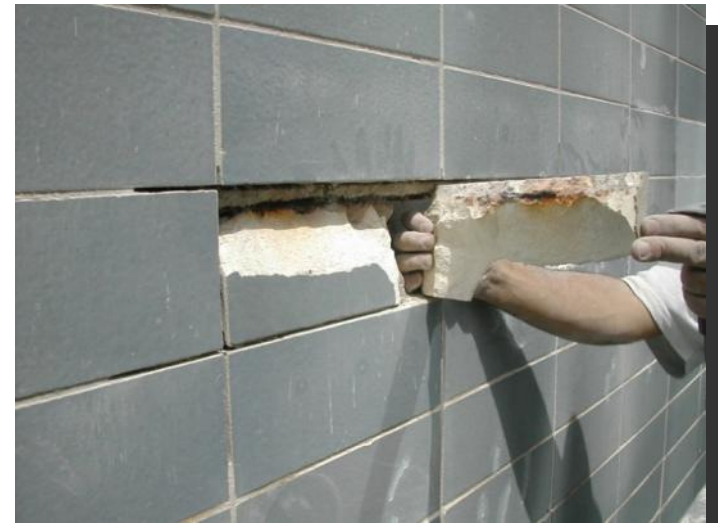
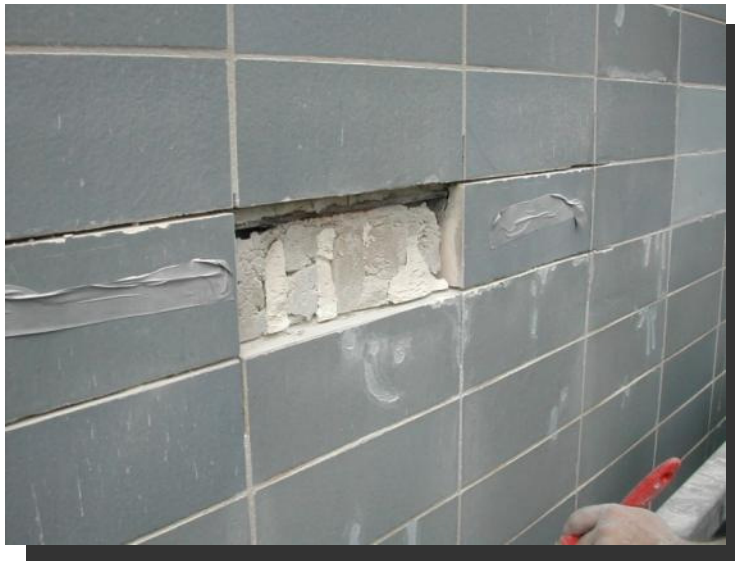
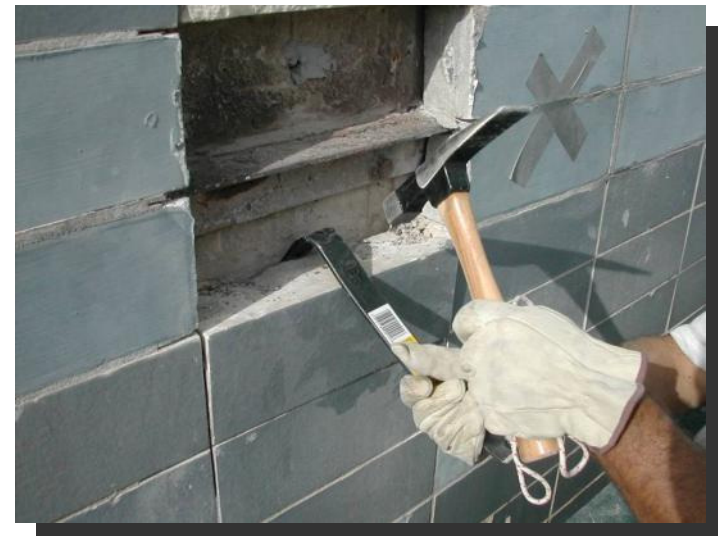
### Salvage of terracotta units

- Saw cut joints
  - Sacrifice first unit
  - Prise / lever out unit below
- ....little success!

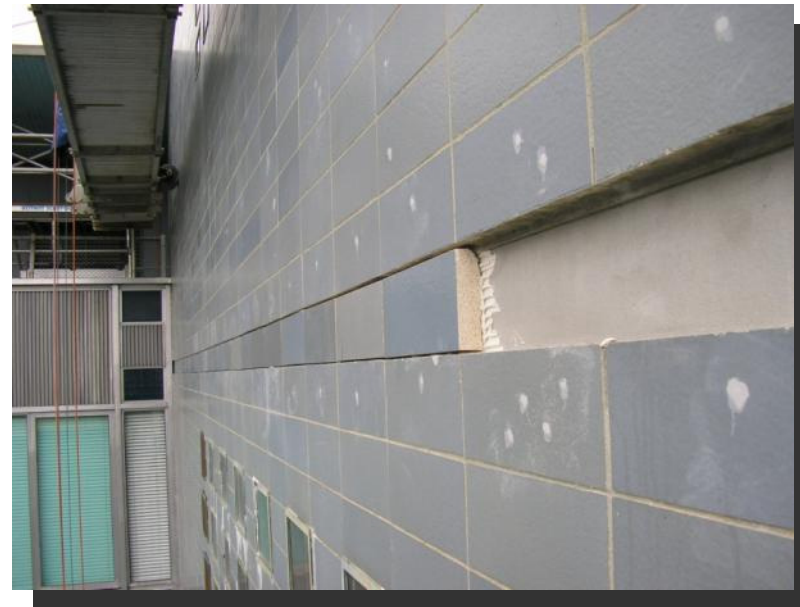
## Shelf angle spacing

- Pre-existing locations not regularly spaced
- New locations to limit stacking to 2 storeys

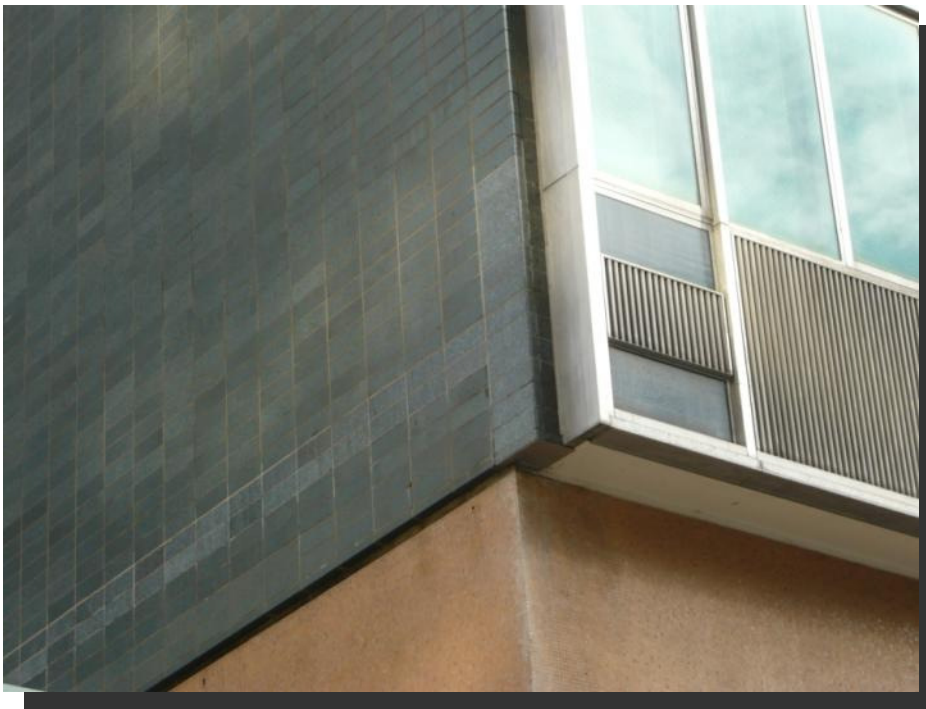
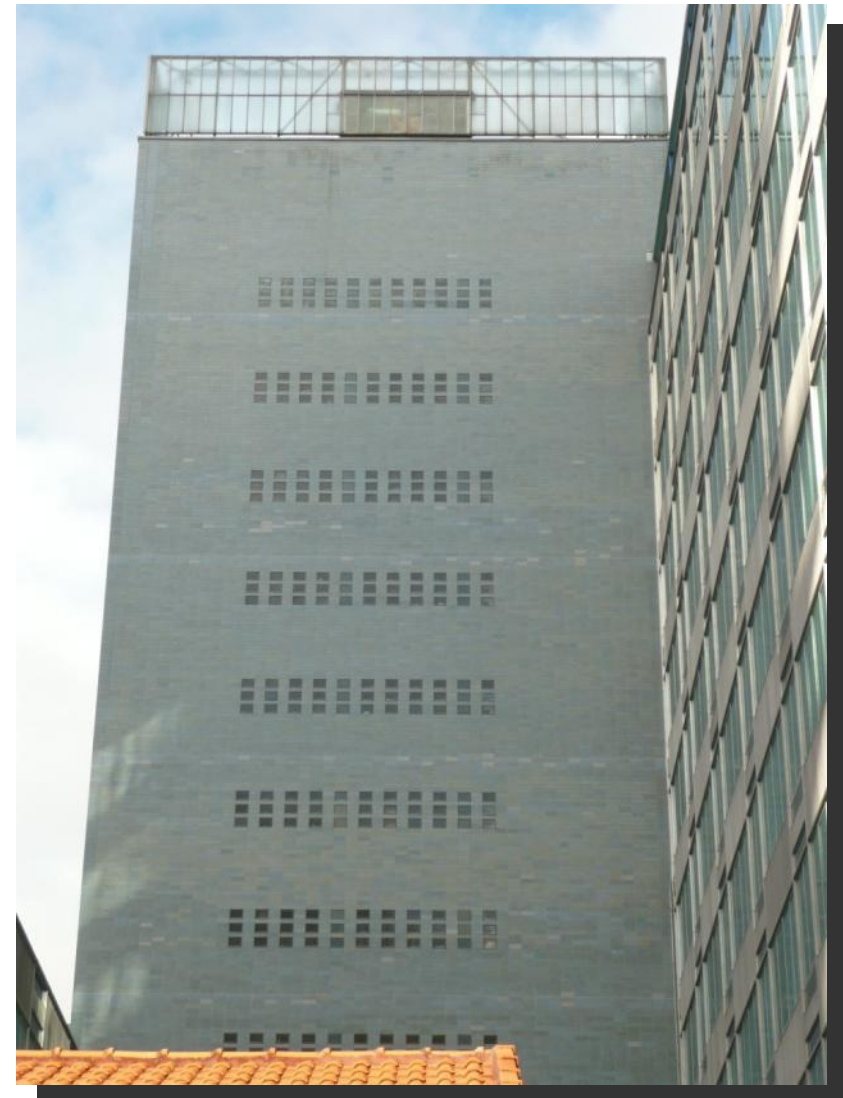
## Colour variation

- Plain tiles greater than pulsachrome tiles
- Difficult to match variation

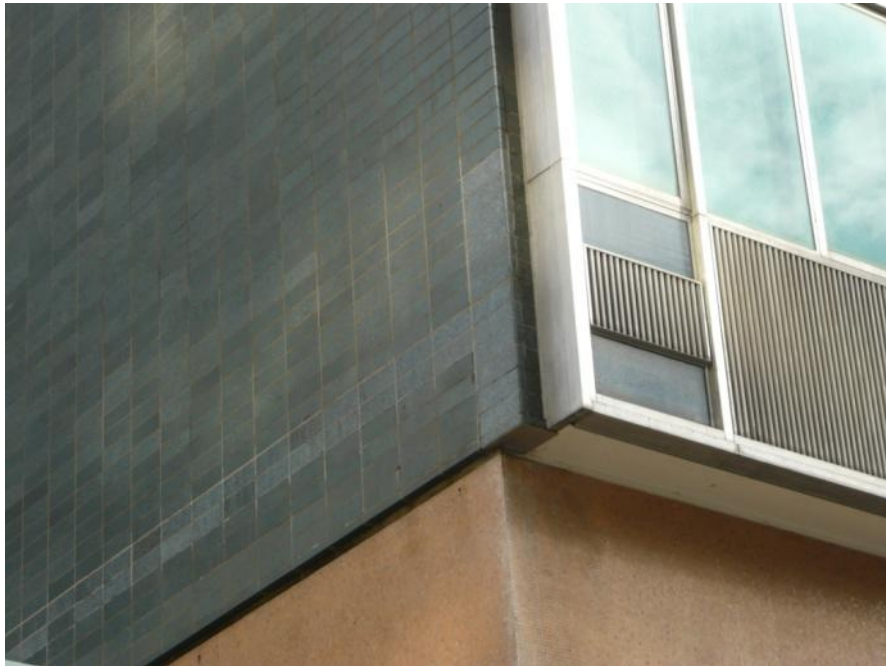
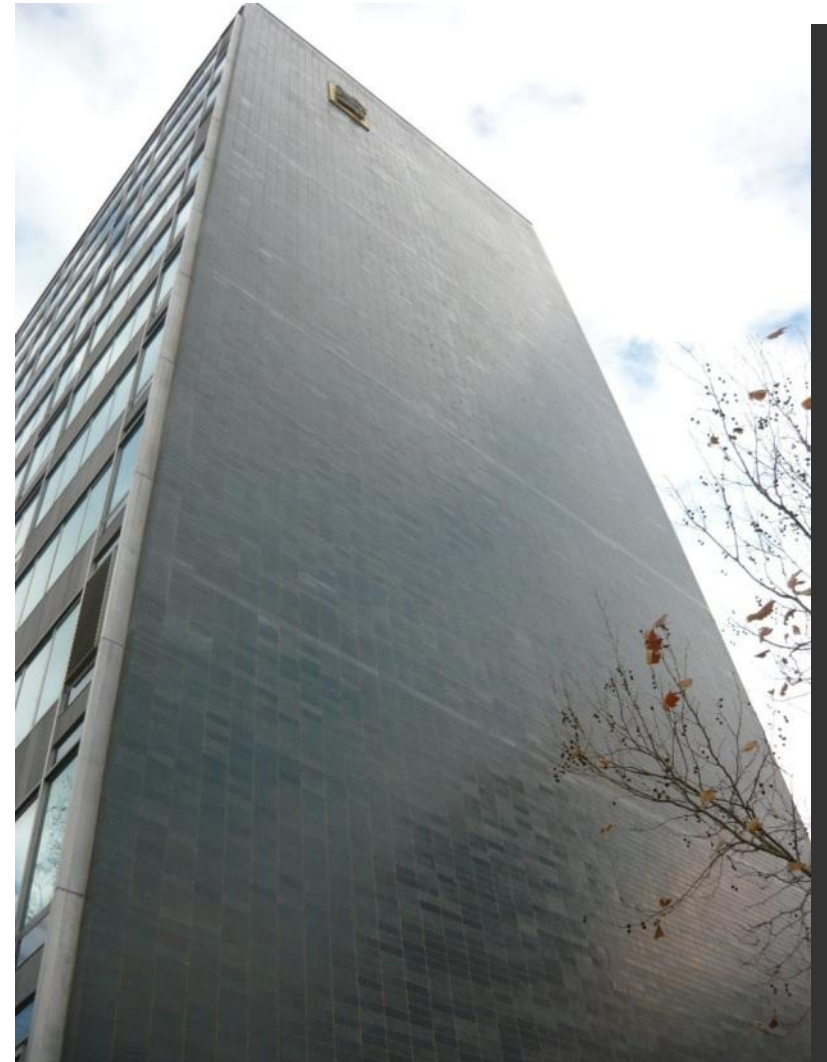
Colour match of glaze  
depends on lighting  
conditions
