Evolution of Stone Cladding Technology: monitoring and intervention techniques for stabilization

(Un) Loved Modern Conference 2009 Sydney, Australia

Kyle C. Normandin and Michael J. Scheffler Wiss, Janney, Elstner Associates, Inc.

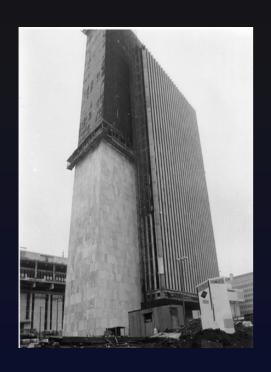
- A. B. D.
- A. Agency Building, 20 Story Building Installation of Vermont Marble Dimension Stone Panels
- B. Agency Building Plan Section Drawing, Detail Vertical Section Pin anchor at shelf Angle
- C. Agency Building, Spall Deficiency D. Marble Panel out of plane, as highlighted by tangential light

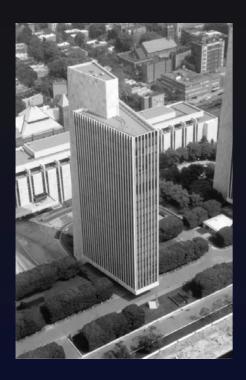
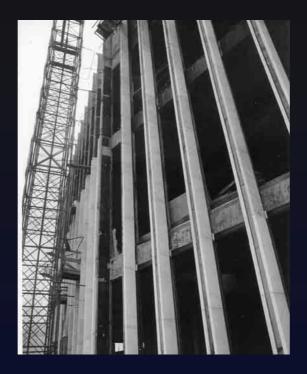
- A. B. C
- A. Agency Building, 20 Story Building Vermont Marble Stone Clad over concrete fins
- **B.** Corning Tower, 40 Story Building- Installation of Vermont Marble Dimension Stone Panels
- C. Corning Tower, 40 Story Building- Exposed anchor deficiency of Vermont Marble Panel

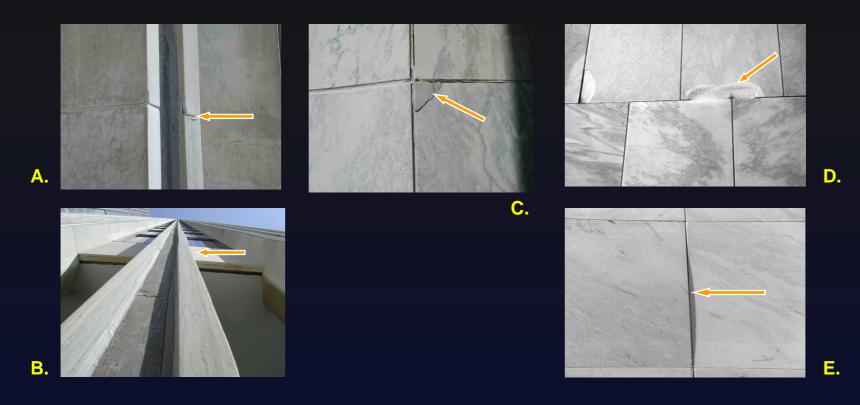
Marble Cladding: Deficiency Categories

- A. Crack at Marble Panel Backside *Incipient exfoliation of Marble Panel*
- **B.** Lean Top at Marble Panel Marble panel shift out of plane or panel bow
- **C.** Spall at Upper Left Spall Deficiency **D.** Spall at Anchor Spall Deficiency at Anchor
- **E**. **Panel Lean Lower Right -** *Panel shift out of plan, as highlighted by tangential light.*

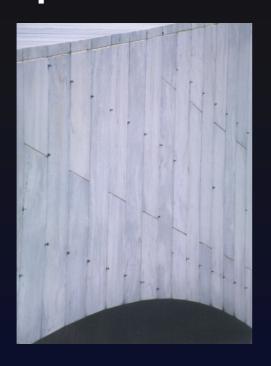
Marble Stone Cladding: Previous Repairs

- A. Threaded Bolted Rods through Panel Wall
- **B.** Random Traditional Dutchman Repairs at Marble Fascia
- **C.** Anchor Bolt Stabilization through Marble Fascia

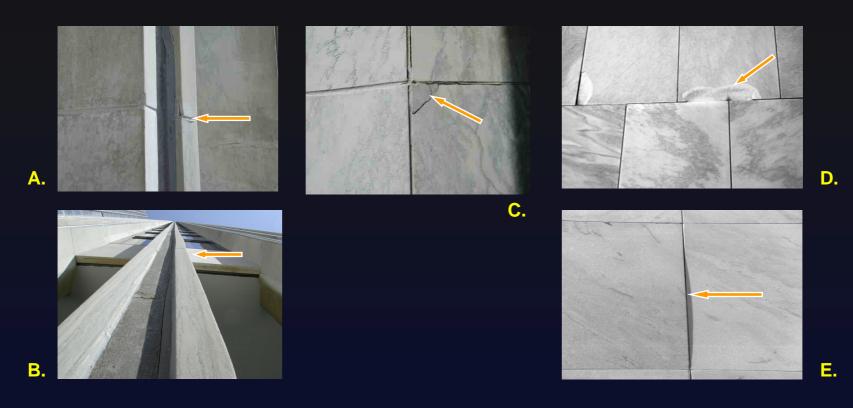
Marble Stone Cladding: Deficiency Categories

- A. Crack at Marble Panel Backside *Incipient exfoliation of Marble Panel*
- **B.** Lean Top at Marble Panel Marble panel shift out of plane or panel bow
- **C.** Spall at Upper Left Spall Deficiency **D.** Spall at Anchor Spall Deficiency at Anchor
- **E**. **Panel Lean Lower Right -** *Panel shift out of plan, as highlighted by tangential light.*

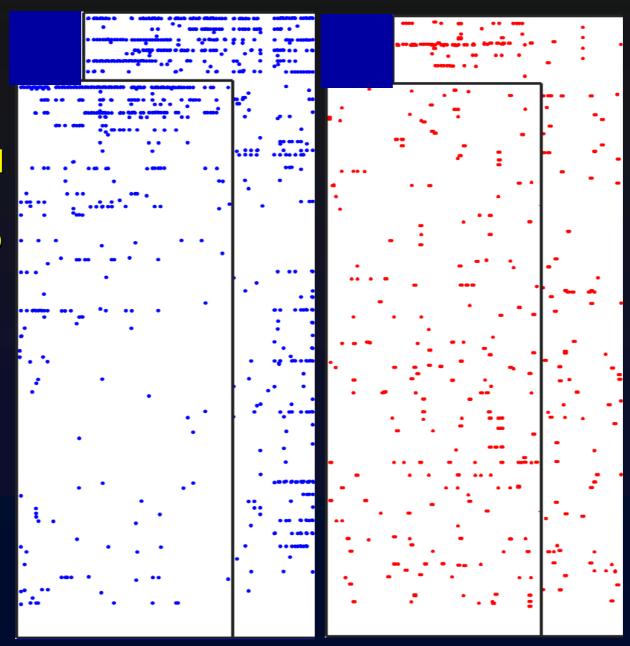
PATTERNS OF MARBLE DISTRESS

Cracking is concentrated at higher areas and corners of tower corresponding to higher wind speed

Spalling is randomly distributed

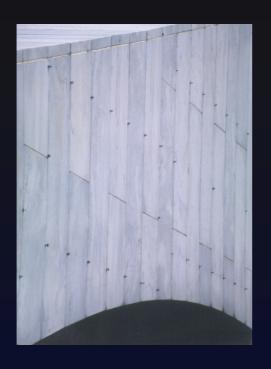
Marble Stone Cladding: Previous Repairs

- A. Threaded Bolted Rods through Panel Wall
- **B.** Random Traditional Dutchman Repairs at Marble Fascia
- **C.** Anchor Bolt Stabilization through Marble Fascia
