Fooling the Eye: Investigation of Finishes at the Boyd House II

Natica Schmeder

The author was engaged to undertake an analysis of the external and internal finishes of Robin Boyd's former home at 290 Walsh Street, South Yarra, for its current owner, the Robin Boyd Foundation.

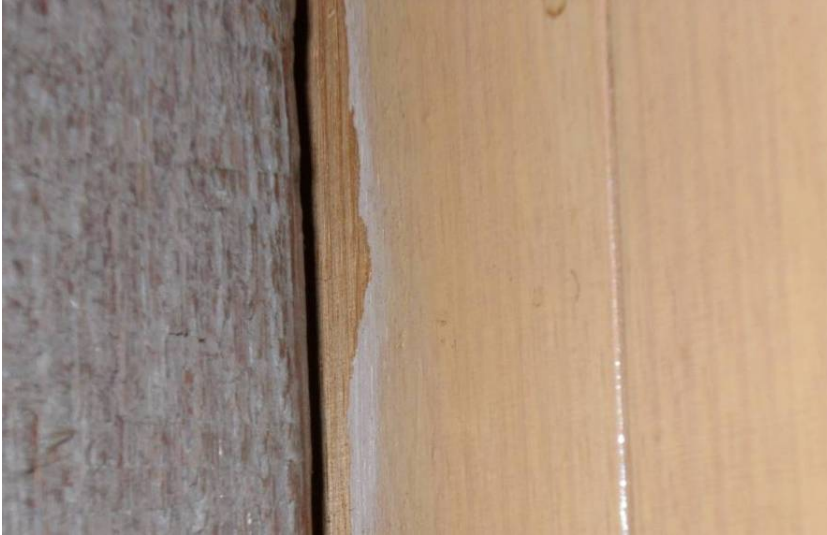
The mountain ash joinery was finished in situ, leaving exposed timber where it abuts a structural post (see Figure 1). A white paint was applied and then mostly rubbed away (as shown by the cross-section, Figure 2). This was followed by a pale varnish.

Figure 1. Left to right: Rough-sawn Oregon post with silver-grey coating; ash joinery with unfinished strip, edge of limed finish showing white undercoat, and with varnished top coat (N Schmeder, 2014).

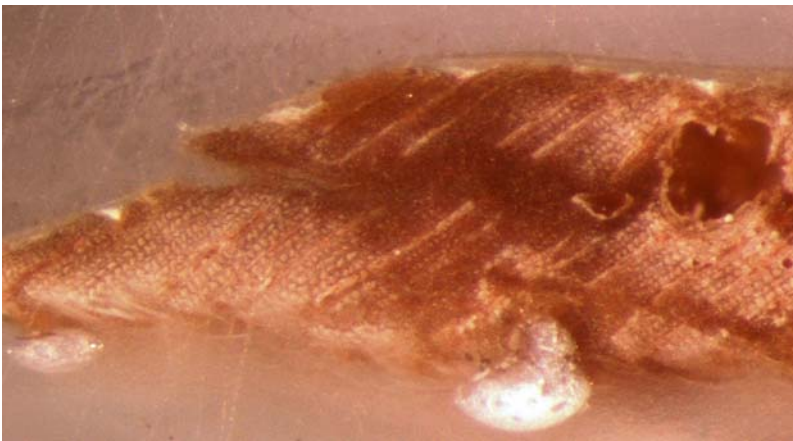
Figure 2. Limed finish of an internal door in the rear (children's wing), as seen in a cross-section under a reflected light microscope (63x). The large brown area is timber, with small amounts of white paint visible in indentations on the surface, beneath a layer of transparent varnish. (N Schmeder, 2014)

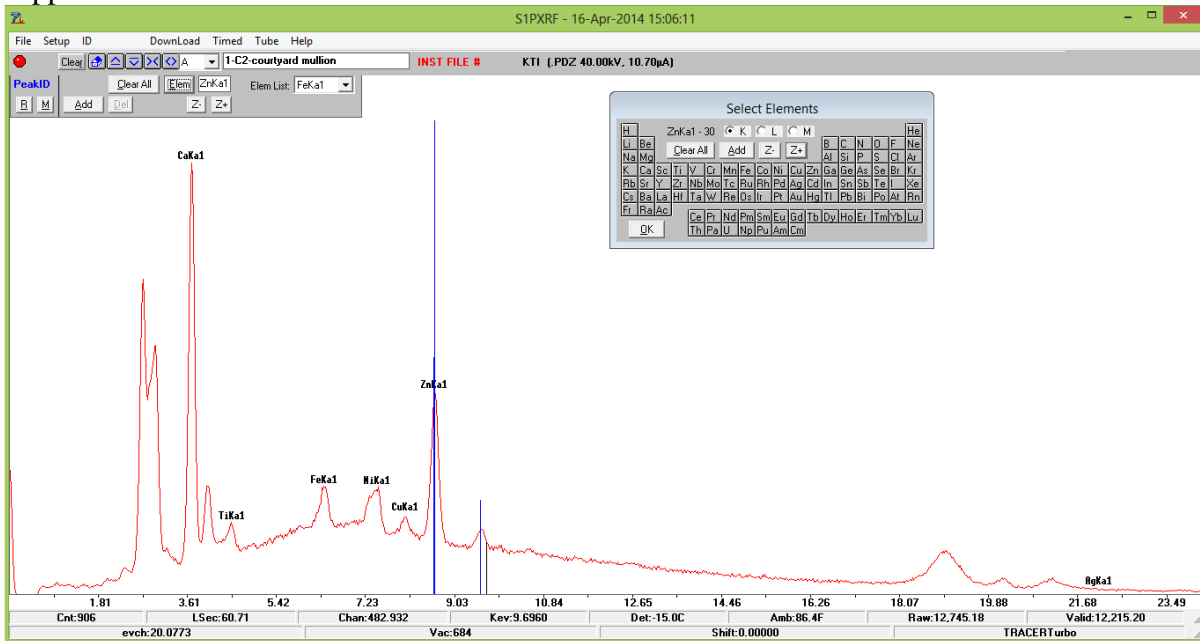
One finish was found exclusively on the mullions of the courtyard walls (north and south sides). It included a large amount of calcium, zinc, a bit of titanium, a bit of iron, and a tiny amount of copper and arsenic.

Figure 3. XRF spectrum for a courtyard mullion. It has a very strong peak for calcium (left), and strong for zinc (right), with small peaks in between for titanium, iron, nickel and copper. The blue line to the right of the zinc peak indicates the presence of a small amount of arsenic. (CCMC, 2014)

In summary, it appears to be far more likely that the paint found on the courtyard mullions was based on limewash. Certainly lime was used on the building site, in the cement-lime mix for the bagging on the bricks, and it appears that limewash was used directly on the bricks prior to applying the bagging.

The sheer silvery-grey colour and the presence of other inorganic elements detected by XRF indicate that the limewash was supplemented by other white (and black) pigments, to provide a greater degree of coverage and as a colourant. The zinc and titanium detected are believed to be from white pigments: zinc oxide and titanium dioxide, both common in the 20th century. The presence of iron may indicate the use of Mars Black (Fe_3O_4), a strong black pigment developed in the 20th century. It is likely that these three pigments were introduced into the mix in the form of a pre-mixed grey paint (probably a waterborne emulsion paint, available since the late 1940s, that would be miscible with limewash). The trace amounts of copper and arsenic correspond to the initial CCA preservative treatment.

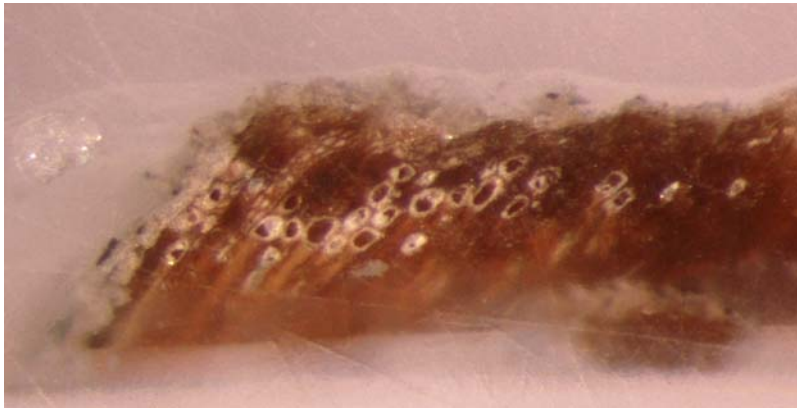
Figure 4. Microphotograph (40x) of a sample taken from the outer face of the balcony door (east elevation of front wing). The large brown object is the timber, with a very thin coating of grey paint on its upper and left-hand edge. (N Schmeder, 2014)

In all cases, the chemical elements detected were, in order of quantity, the most zinc, less lead, less titanium, and a tiny bit of iron. As in the case of the courtyard mullions, it is believed that the zinc and titanium are white pigments in the form of oxides, and the iron is from Mars Black – creating the pale grey colour. Lead is believed to be lead white, the most important white pigment since ancient times, used for house paint until 1970. For architectural uses, it was most commonly mixed with linseed oil, as it acted both as a pigment and drying agent, making an opaque, fast-drying and durable coating.

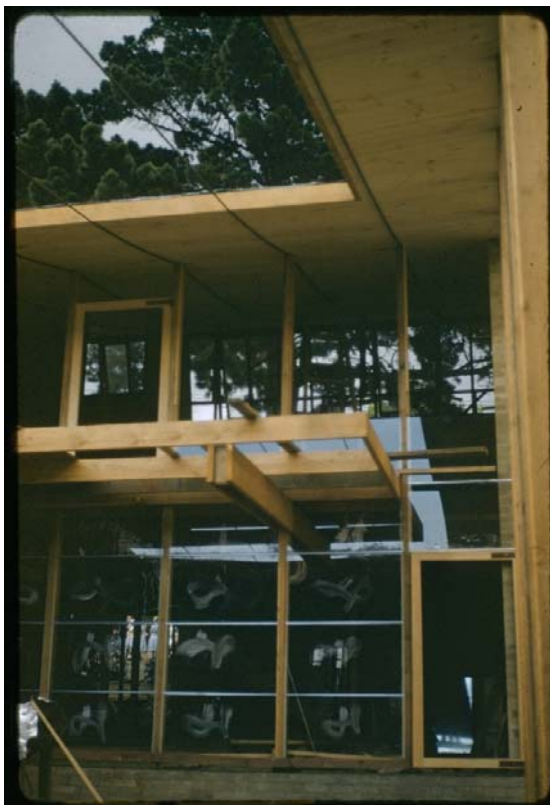
These results make sense comparing photos from when the Oregon frame was being erected in 1958, with those taken a year or two later. The pale yellow wood seen in 1958 had already changed colour dramatically to the same silver-grey we see today. CCA on its own would not have greyed off that quickly, nor would bare wood have weathered that fast.

Figure 5. Courtyard elevation of the Boyd House while under construction in 1958. Note the fresh yellow Oregon timbers. (Peter Wille, Collection of architectural slides, State Library of Victoria)

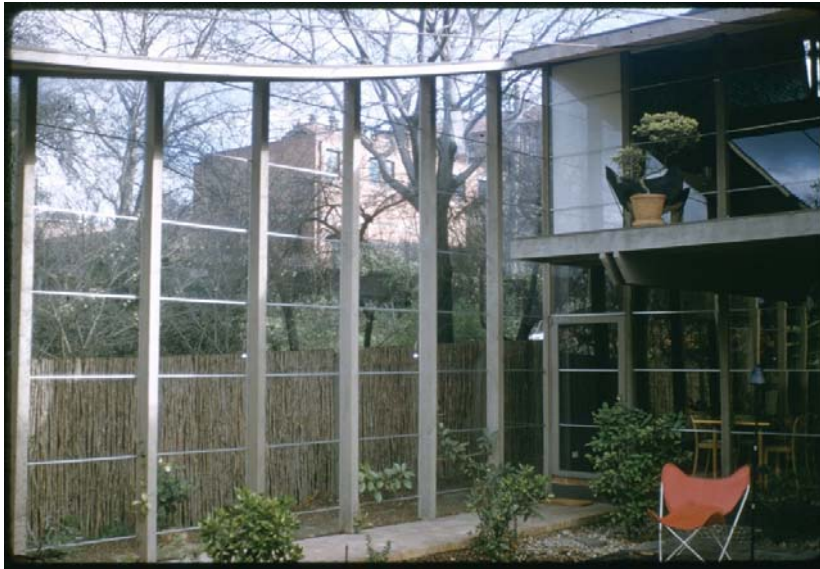
Figure 6. Courtyard elevation of the Boyd House c1959. Note the greyed off timbers of the front wing and the courtyard mullions. (Peter Wille, Collection of architectural slides, State Library of Victoria)
