# SOLOMON R. GUGGENHEIM MUSEUM

## EXTERIOR RESTORATION AND BUILDING ENHANCEMENT

Pamela Jerome, AIA

WASA/Studio A

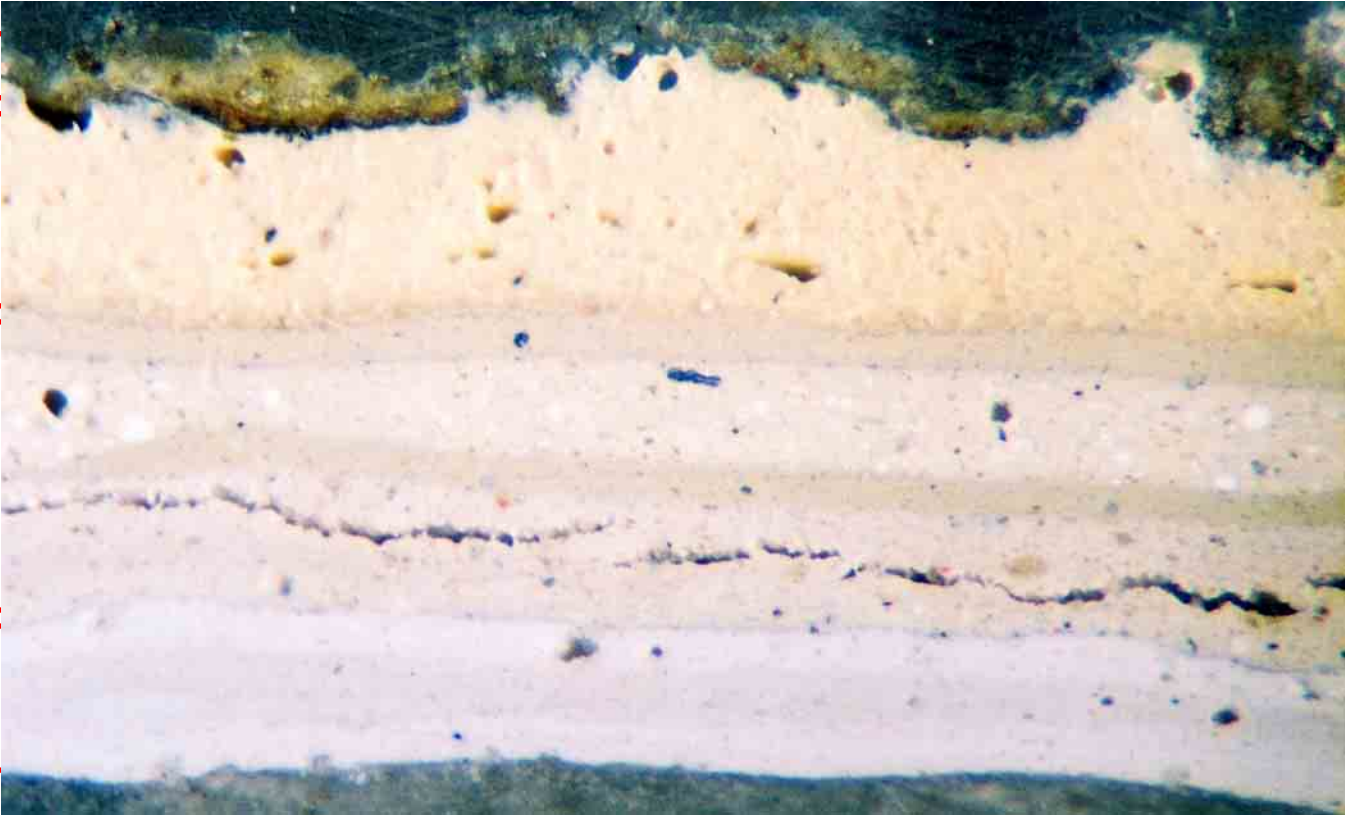
Sample 35B (~30x) – First Level West Thannhauser

Shotcrete  
Original primer  
and Cocoon  
1963 – 1991?  
four layers  
1992 – present  
four layers

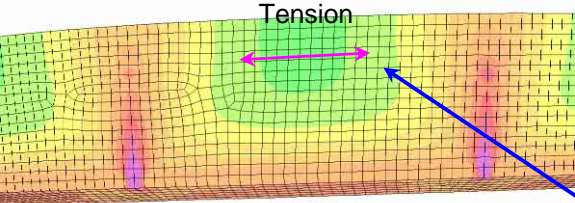
A. Stress contours in the circumferential direction due to thermal expansion

- Correlates with exist. vertical cracks

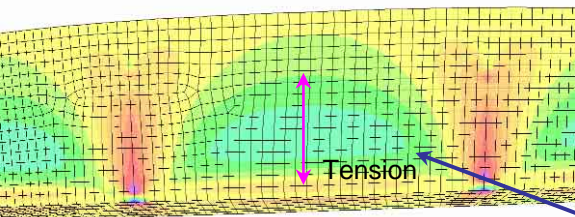
B. Stress contours in the vertical direction due to thermal expansion

- Correlates with exist. horizontal cracks

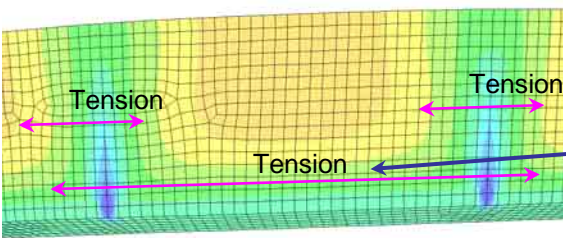
C. Stress contours in the circumferential direction due to thermal contraction

- Correlates with exist. vertical cracks at web walls and 4" apron slab

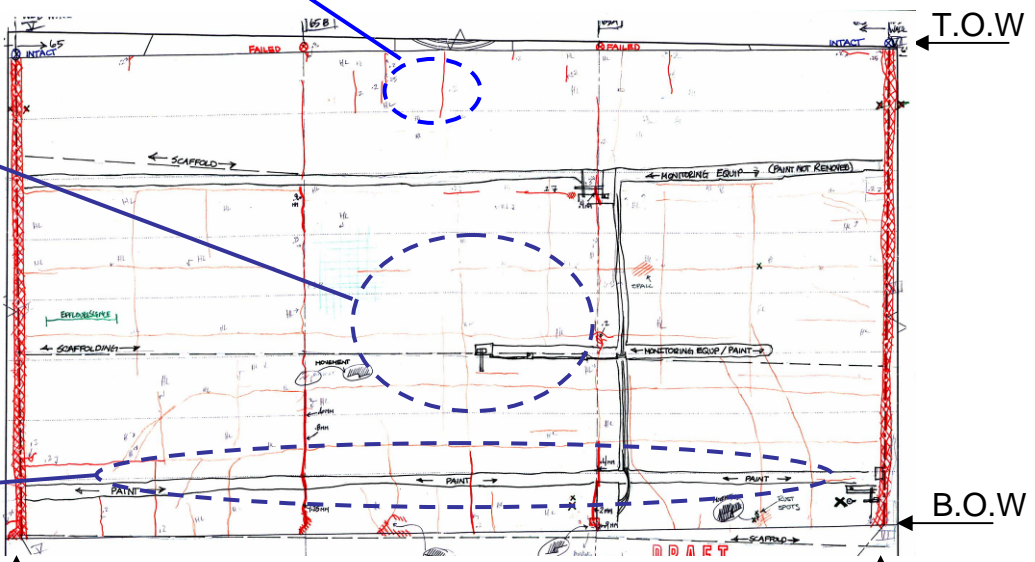
Existing Cracks at Bay 65 between Web Wall V and VI
