## WALTER BURLEY GRIFFIN INCINERATOR, WILLOUGHBY – CONCRETE REPAIRS

Paul Connett

*Hughes Trueman Consulting Engineers, Sydney, Australia*

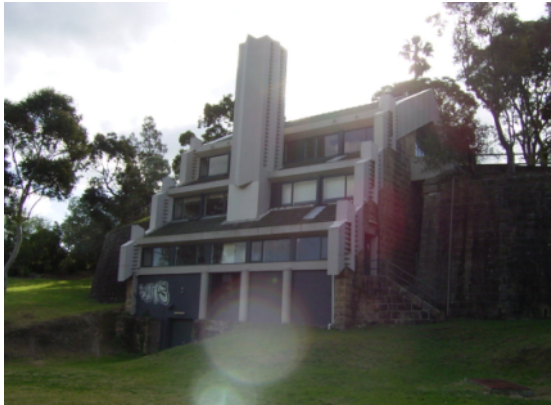
Figure 2: Incinerator in July 2004  
View from south-east. Delivery floor at the top, trimmer's floor, furnace floor and ash floor below.

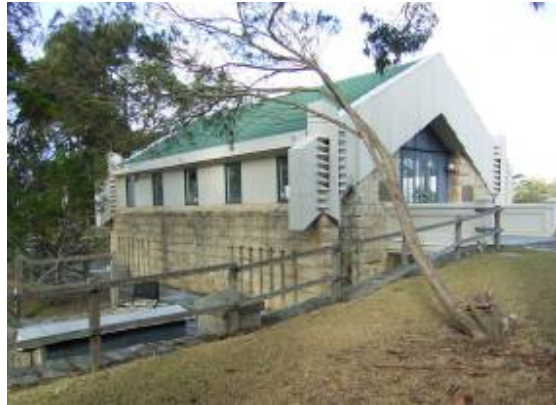
Figure 3: Incinerator in July 2004  
View on the delivery floor from north-west.

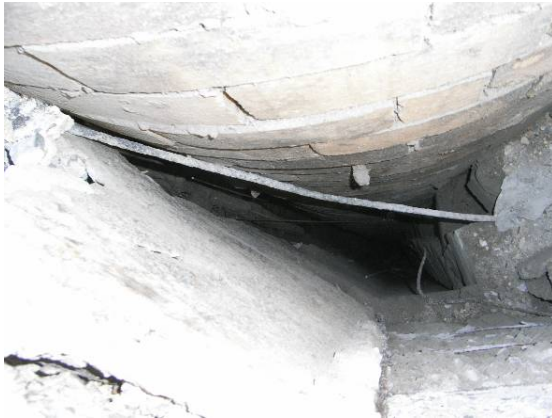
A full access scaffold was erected and the 1980's chimney cap removed, allowing the internal faces of concrete between the brick flue and outer concrete to be viewed. The internal face of concrete for at least 3.3m below the top was very friable with negligible strength and large areas of delamination. The condition was much worse than previous core sample test reports had predicted. In addition, there were numerous rogue steel bars projecting into the internal chimney space from the concrete (possibly original shutter ties). The interior of the chimney was lined with flue bricks, with a small space between the flue bricks and the outer concrete chimney. In discussion with the contractor it was agreed that installation of ICCP to the upper portion of the chimney as existing was not practicable given the severe extent of deterioration of reinforcement and concrete and restricted access between the flue lining and concrete. Had the flue bricks alone been removed patch repair would have been extremely uneconomic, whilst maintaining the structural integrity of the chimney, because of the extent of concrete and reinforcement replacement required.

Figure 4: View down the chimney from the top with c.1980's cap removed showing the general extent of delaminated, friable concrete.

Application was made to the NSW Heritage Council for the top 3.6m of the chimney to be carefully taken down and reconstructed, with provision to takedown and rebuild a further 1.8m, or so, should this be found to be necessary. It was considered most important not to demolish to below where the chimney exits the building and to retain the bottom height of chevron and inverted diamond-point detail, to allow the chimney to be reconstructed to its previous form from an existing base.

In total approximately 5m height of chimney was carefully taken down, together with the brick flue lining. Deterioration of concrete and reinforcement was found to continue below this level, to as far as the trimmer's floor. Because we did not want to lose the form of the chimney above the roof a structural scheme has been devised to carefully remove corroded reinforcement and friable concrete from the inside of the chimney whilst stabilising the external veneer of sound concrete using a reinforcement armature and sprayed or rendered concrete backing. A concrete, vertical transfer structure will then be constructed inside the chimney to permanently retain the external concrete veneer and provide a structurally sound base from which to reconstruct the chimney in concrete to Griffin's original design and height.

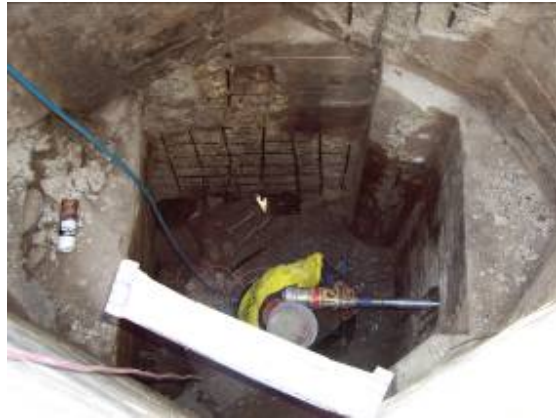
Figure 5: View inside chimney with flue bricks removed, showing typical extent of reinforcement corrosion.
