RESTORING FRANK LLOYD WRIGHT'S SOLOMON R. GUGGENHEIM'S MUSEUM

Pamela Jerome, AIA, LEED® AP
Partner, WASA/Studio A

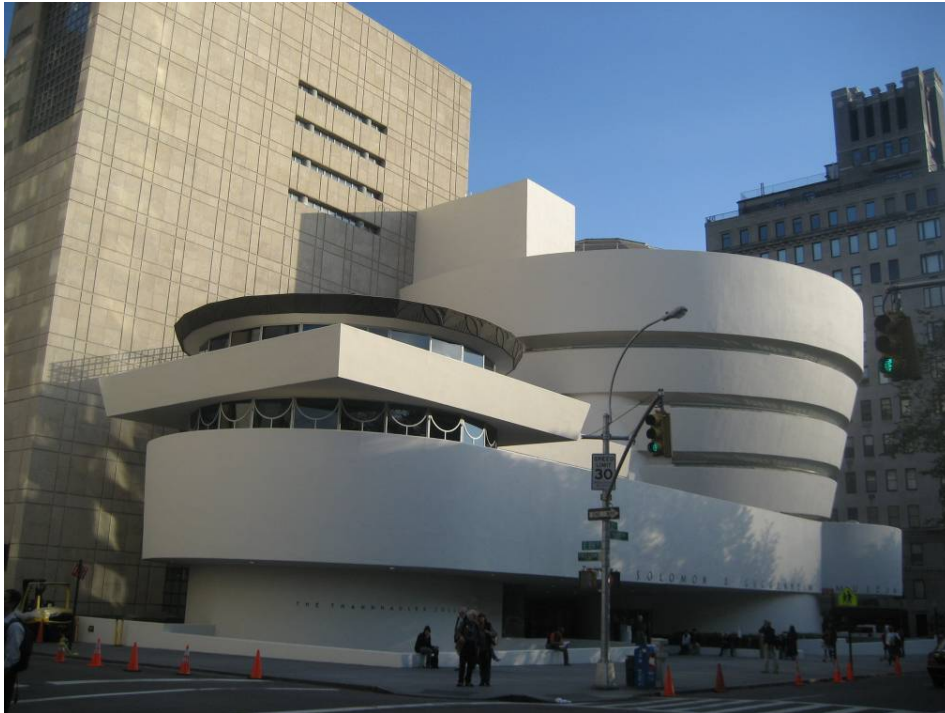
Fig. 1: The Solomon R. Guggenheim Museum after restoration. (All photos by Angel Ayón of WASA/Studio A, courtesy of the Solomon R. Guggenheim Foundation.)

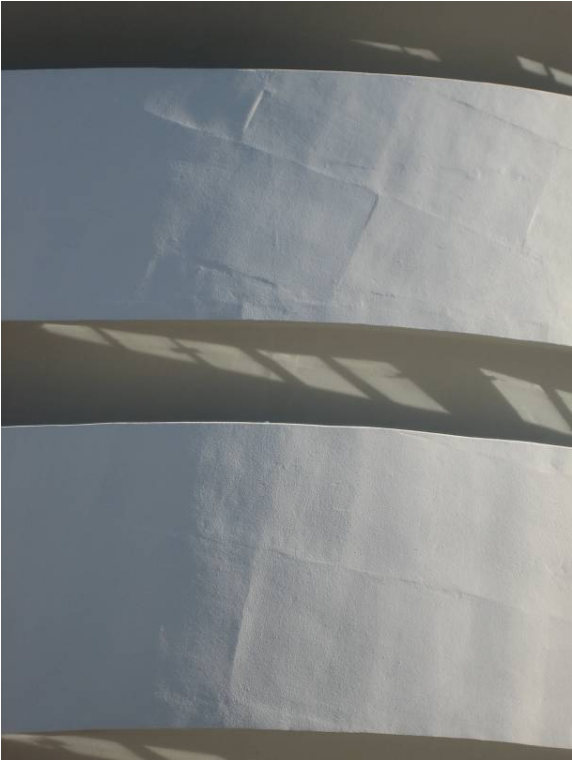
The museum, once stripped of its multiple layers of paint, was revealed as remarkably hand-crafted. Formwork marks are visible in raking light even through the paint (Fig. 4), but the uncoated shotcrete surfaces exhibited great detail including the imprints of the wood graining from the plywood forms. From archival correspondence, it appears that Wright was expecting a smoother finish. However, the photograph referenced above is evidence that he accepted the final product, however imperfect. Therefore, were the surface marks to be considered defects or evidence of authenticity of craftsmanship?²² We opted for the latter approach.

Fig. 4: Formwork marks were deliberately retained on the restored façade and were treated as evidence of authenticity of craftsmanship.

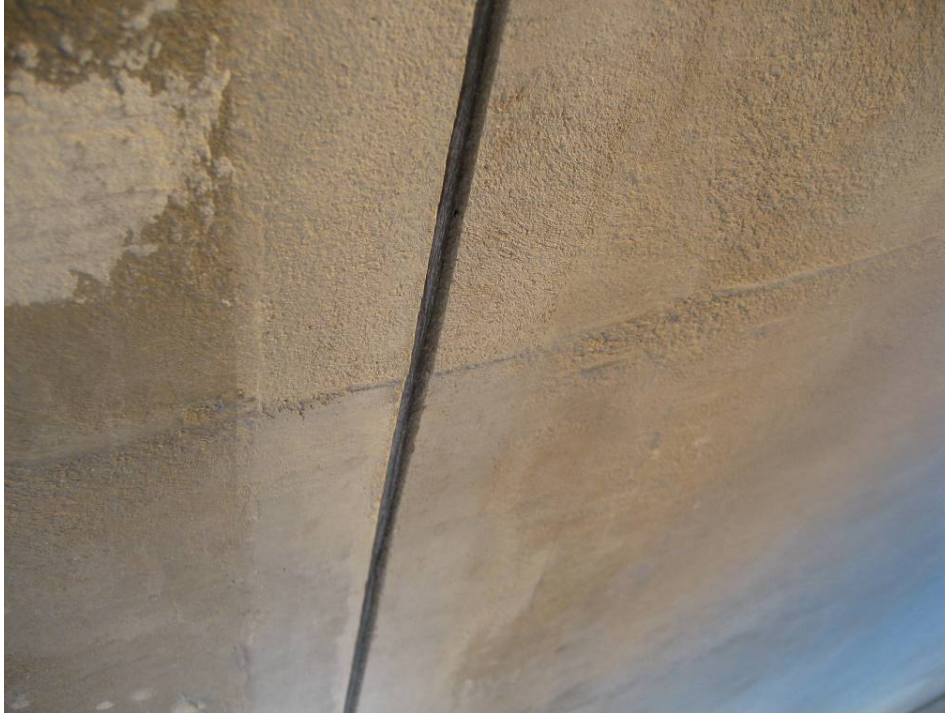
Fig. 5: Patches carefully recreated the texture and board-form marks. This patch is at the sixth floor ramp wall, where vertical control joints remedially installed during the 1992 work were retained.

In addition, the contractor, who applied the patches and crackfillers using the specified compatible compound, carefully recreated the texture of the surface as well as the formwork marks (Fig. 5).²⁴ Yet our choice to leave the evidence of the original workmanship may continue to be perceived by critics as marring the surface.

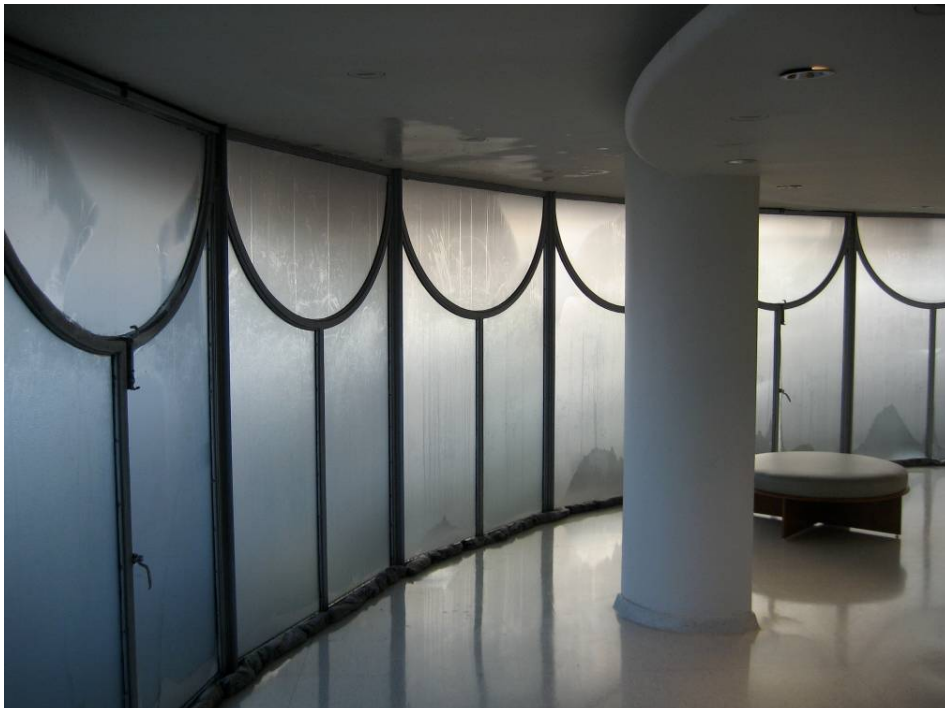
As stated earlier, as preservationists we strive to maintain original building fabric. However, there comes a point where a building's use may take precedent. That point arrived when it came to the Guggenheim's original single-glazed steel window walls and aluminum skylights. Although the fabric of both types of units was in remarkably good condition, fluctuations in New York City's temperatures permitted condensation to form on the interior of the glazed surfaces during the coldest days of winter months (Fig. 6).

Fig. 6: Excessive condensation was an issue and the reason for not retaining the original single-glazed windows and skylights.

Numerous design attempts were made to retrofit the existing sash of both windows and skylights, thereby saving the original fabric. In the case of the windows we found that we could not accomplish this without seriously compromising the interior aesthetics (Some of the museum's interior spaces are also a New York City-designated landmark.) In addition, for both glass walls and skylights, the retrofit designs would not provide a true thermal break. After much deliberation, a decision was made to recreate the windows and skylights.

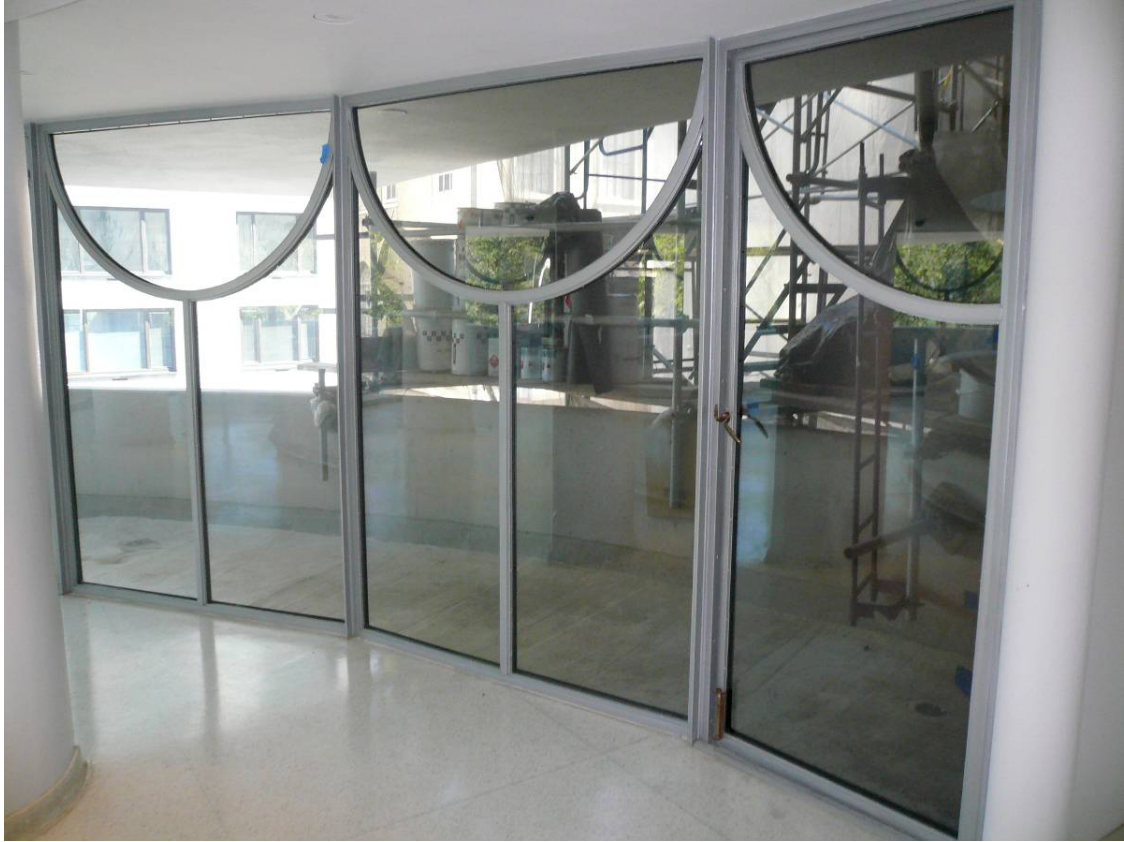
Fig. 7: The new windows replicated the existing in thermally broken steel.

For the windows, this resulted in the unprecedented step of fabricating thermally broken steel replicas with double-glazing (Fig. 7).²⁷ With the skylights, it was much easier to find a manufacturer to recreate the aluminum profiles with thermally broken double-glazed units. Discrete improvements were made to the original design of the skylights, which are not actually visible at the interior because of the lay-lights and are recessed in shadow on the exterior, as the upward advance of the building's spiral shape overhangs each floor below.
