Authenticity and an Original Designer at Louis Kahn's Trenton Bath House

Anne E. Weber, FAIA

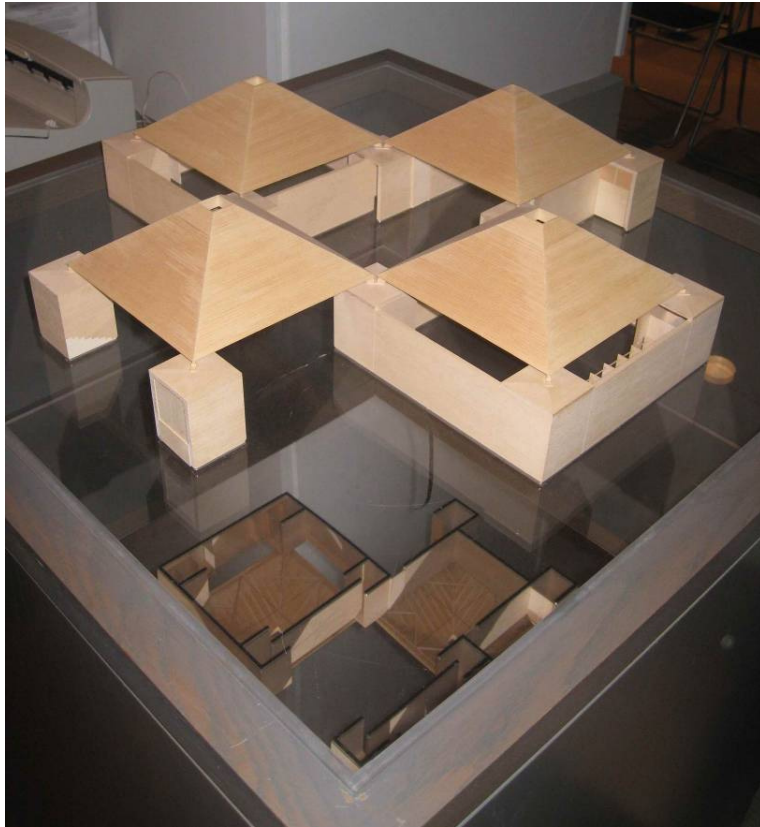
Figure 1: Model of the Trenton Bath House on display at the University of Pennsylvania.

The design work was productive for Louis Kahn, despite the lack of commitment from his client. He attributed the germination of his philosophy of servant and served spaces to the Trenton Bath House. This nine-square plan is based on a tartan grid, with the narrow zones providing the square corner piers and rectangular servant zones. The corner piers are the primary structure of the buildings, and also serve for entrance, storage, access to vaults, and shelter for toilet facilities. The rectangular zones provide for circulation around the inner square focal point of each structure, and at the locker rooms provide natural light.

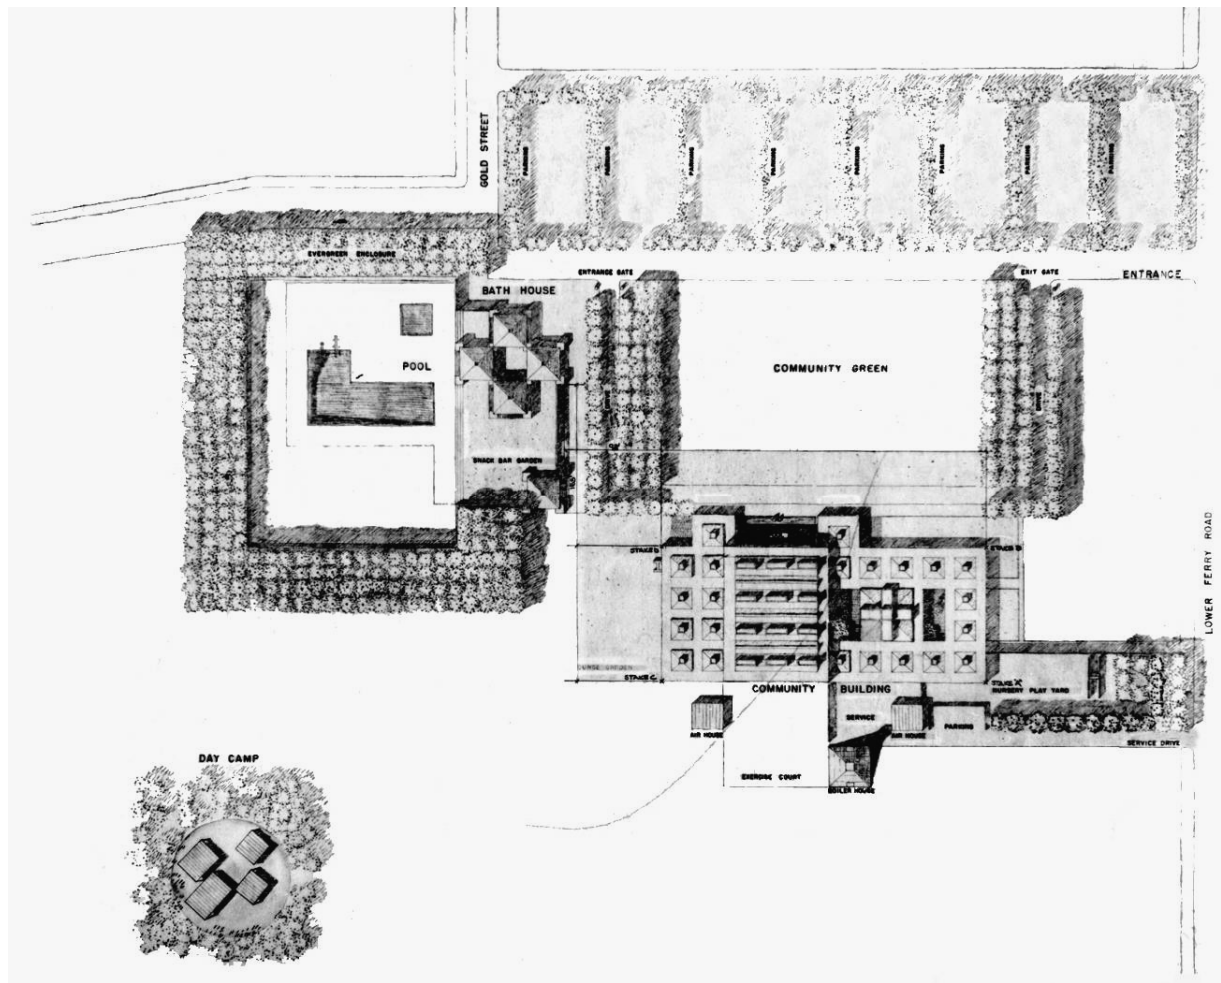
Figure 2: Kahn's 1956 site plan for the JCC. The current Community Center sits much closer to the Pool complex than in this design.

The Bath House designs also foreshadow other of Kahn's work, such as the Salk Institute and the Kimbell Museum in the treatment of landscape. The Trenton site designs focus on the creation of rooms, largely through closely placed tree bosques. The landscaping creates a progression of spaces leading to the structures. Even the Day Camp pavilions are shown in vignettes as in a clearing in dense trees, an enclosed outdoor room; in reality, the pavilions are in an open field, and no planting was ever done.

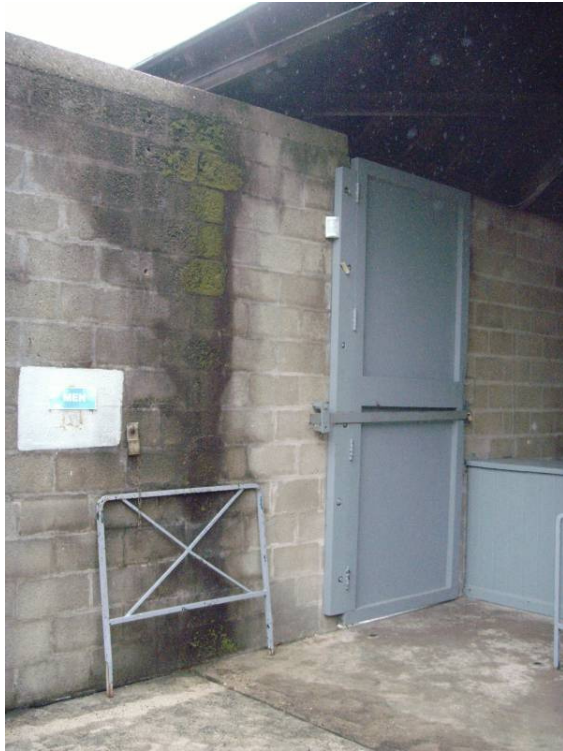
Figure 3: Walls are covered with organic matter where roof run-off occurs.

At the Bath House, the concrete block was covered with mold and moss; the concrete slabs were heaved and patched; and the toilet and shower facilities were dingy and worn. Two walls were near disintegration from water damage caused by roof drainage.

The Bath House is composed of four pyramidal roofs supported from the corner piers. The roofs have no gutters. Below the roofs, the concrete block walls are located either at the interior or exterior face of the corner piers, and in two instances centered on them. Where the walls are beneath the roofs, they are in nearly perfect condition. Where they are outside of the roofs, they are in poor condition at the upper courses where the water has penetrated through the exposed top surface of the block. Mortar has eroded from the joints, and cracks have opened up due to corrosion of the horizontal joint reinforcement. Where the roofs drain directly onto the roofs, the walls are seriously deteriorated, to the point where they require reconstruction. How to treat these walls, and improve conditions to prevent future deterioration, is one of the key issues of the restoration, and one for which the input of the original designer could be very helpful.

Looking at the original drawings, we saw no indication of roof-edge gutters, and no capping on the block walls. Nick Gianopulos suggested that the Bath House was considered by Kahn to be a temporary seasonal building because he did not include roof drainage, as he would have done for a permanent structure. The construction drawings do show gravel-filled circular drainage basins at the centers of the Bath House sides, but the roofs do not reflect this design. Our search of the archives at the University of Pennsylvania turned up a drawing that solved this riddle; the initial design for the roofs were intersecting gables resembling origami, which had valleys centered on the sides of the squares. When our team discussed this drawing and the design intentions for the roof drainage with Anne Tyng, she did not really remember this elaborate roof form, although Nick Gianopulos pointed out to her that it had her lettering on it. She said that she and Kahn had envisioned the water running over the roofs and structure like a ruin, and this vision has nearly been achieved. She said that gutters were never considered, that they would destroy the purity of the forms. So we are faced with solving the problems of water entering the walls and diverting water in an invisible fashion.

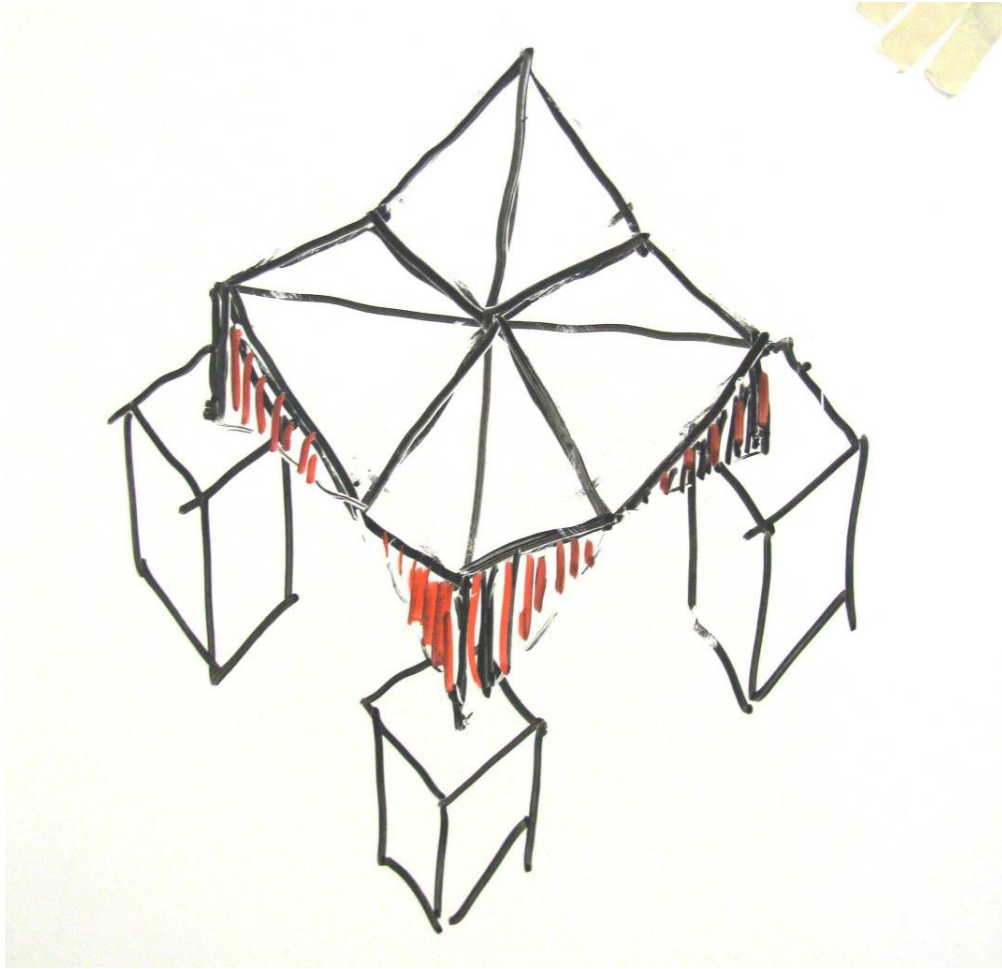
Figure 4: The intersecting gable roofs would have drained water right into the gravel pits.

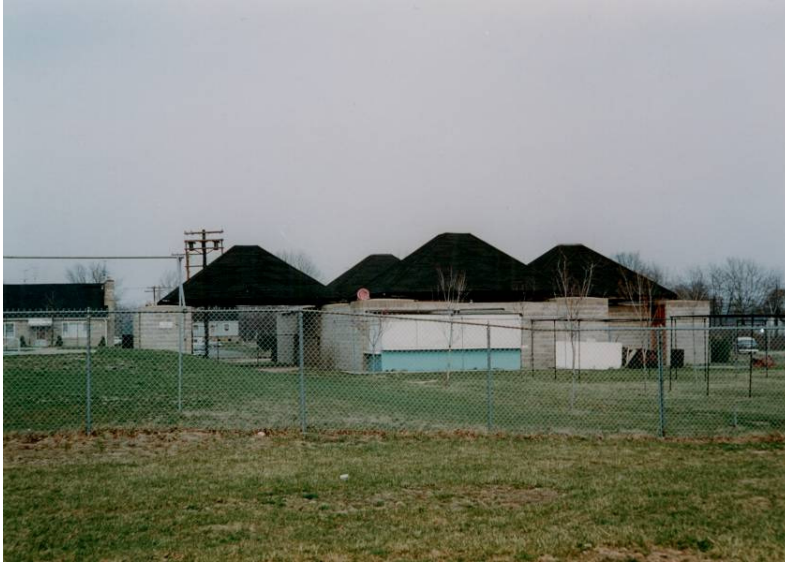
Figure 5: The snack bar shortly after construction of the Bath House. It was enlarged in later years.

A Snack Bar was part of the original program for the Bath House, and Kahn's design drawings show it in three different locations. The Snack Bar was never constructed to Kahn's design, but since it is a vital part of a summer pool club, the JCC constructed one against the wall of one of the pavilions, completely in conflict with the original design. How to place the Snack Bar was another issue with which we looked to Anne Tyng to address.

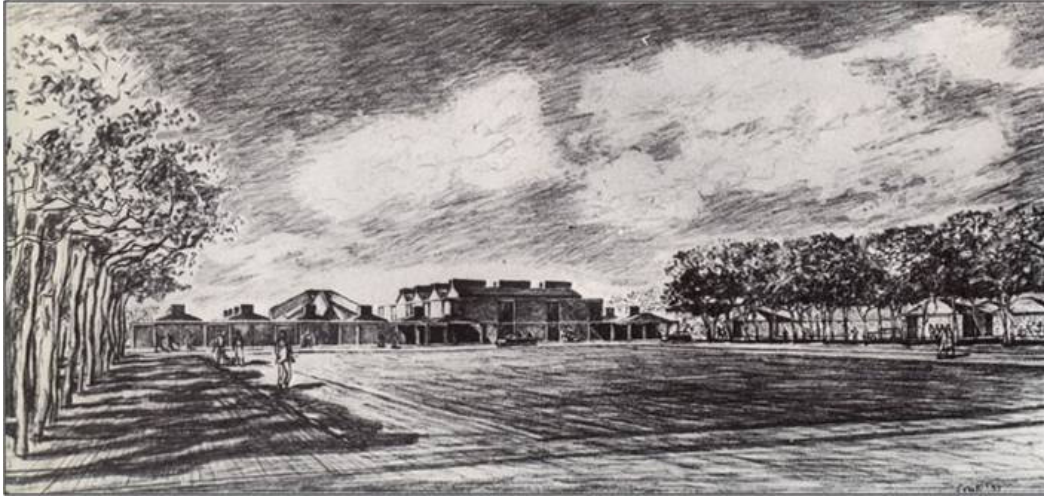
Figure 6: The Snack Bar in the form of one of the Bath House structures is to the right of the community center.

The Snack Bar is shown in three locations – within the Bath House structure at the base of the stair to the pool; outside the pool enclosure near the Day Camp and recreation fields; and at the corner of the pool and Bath House development. This corner location is the most developed in both site plans and renderings, and could be constructed in accordance with Kahn's thoughts quite accurately. This approach raises issues of integrity, and conflict with the Secretary of the Interior's Standards, which state that designs that were never built should not be constructed. Several approaches under consideration by our team included a building of the mass and location shown in the Kahn drawings, but abstracted; a building in a similar location that helps to define the corner of the pool enclosure area; and a bar-type building that defines the edge between the pool complex and the Day Camp area. We discussed the Snack Bar at length with Anne Tyng, and she did not feel that we should be constrained by Kahn's sketches and thoughts, but she agreed that the existing Snack Bar should be removed. More than 50 years later, the building should be of its own time. We have since selected the approach of defining the corner of the pool enclosure, but with a frame structure that does not resemble the Bath House structures.

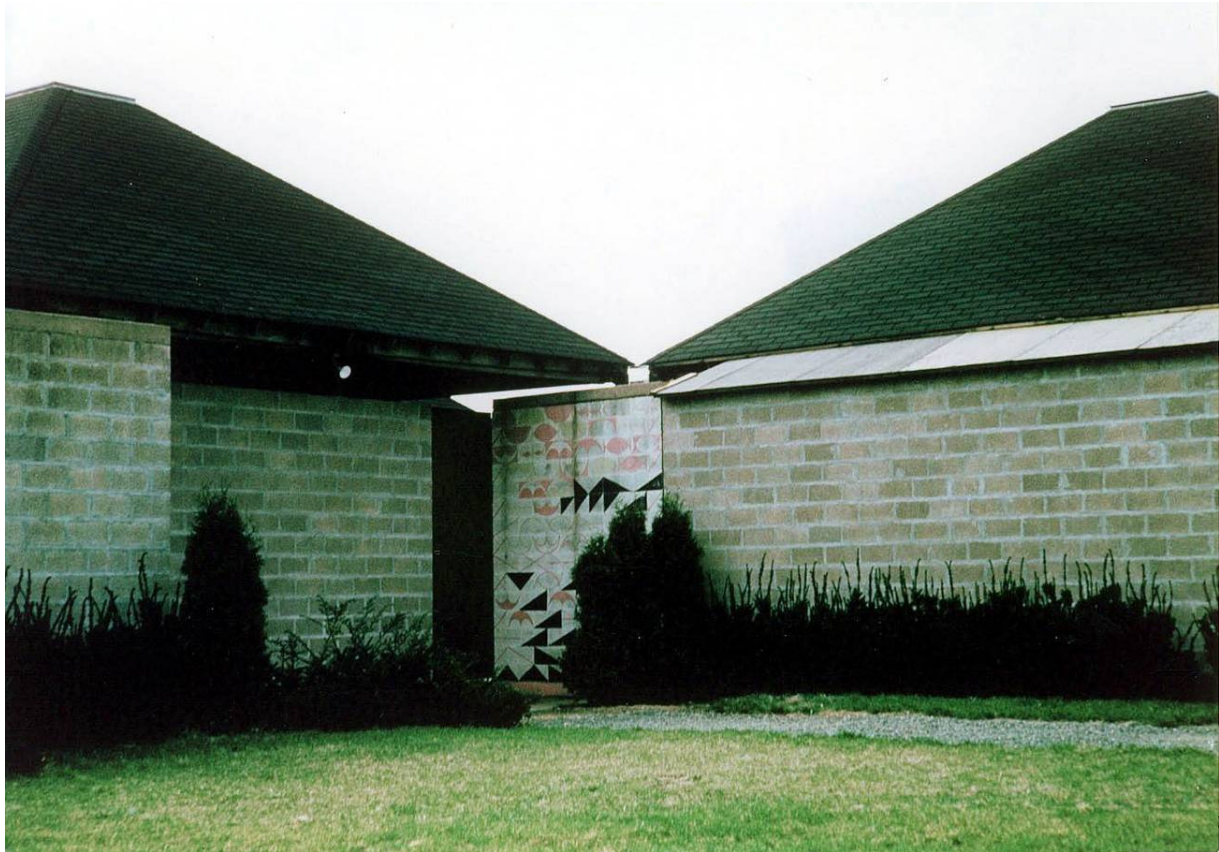
Figure 7: The original mural was adjacent to the entrance. The foundation plantings were not of Kahn's design. (Photo by Jeremiah Ford III, AIA.)

Adjacent to the entrance to the Bath House, Kahn and staff from his office painted a mural on the concrete block wall. It became severely deteriorated, and was painted over. It does not appear to have been of much importance to her, because she did not remember the color palette, or much about it at all. Fortunately, very clear black and white photos exist of the artwork, and a few color photos. If the paint is removed, it may also be possible to trace the pattern so that it can be re-painted with great accuracy. Paint analysis will also be able to confirm the color scheme found in the photographs.
