Conserving the Heritage of Heavy Timber Construction

Jim Staton

Stamper batteries

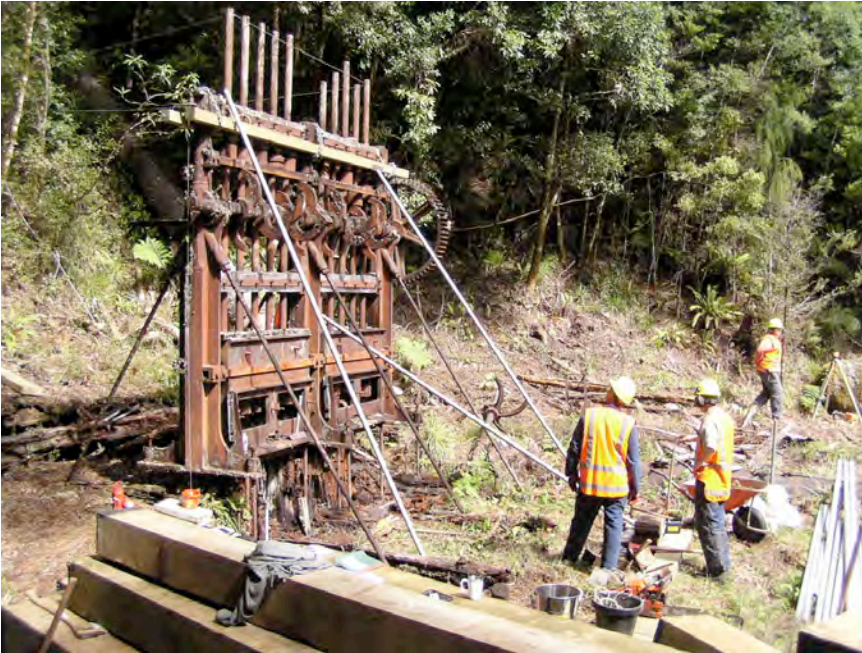
Figure 2: The Golden Lead stamper battery prior to restoring the foundation timbers in 2008 (Jim Staton)

The Golden Lead battery involved removing approximately 4m³ of soil from around the foundation beams then holding up and stabilising an estimated 13 tonne of iron while removing the rotten beams plus site preparation, then manually handling 8.2 tonne of beams into place under the ironwork. Approximately 7m³ of soil and debris was manually removed from the

At the Golden Lead all work was completed on-site as only the foundation crib-work and the top section of the mortar box vertical timbers were replaced.

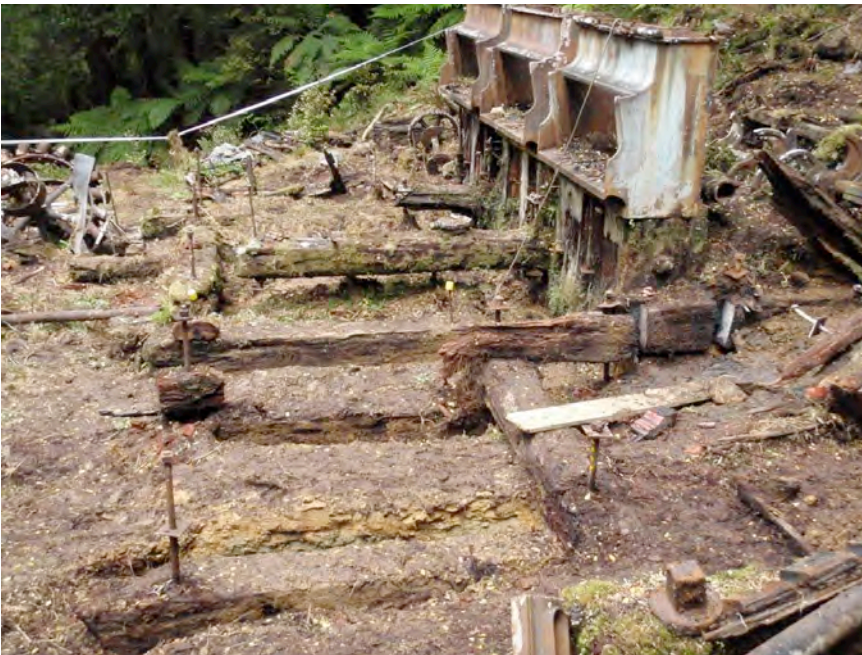
Figure 3: Lord Brassey stamper battery foundation condition 2012 (Jim Staton)

Lord Brassey, all of the foundation beam remnants cleared and all bolts and other iron fittings recovered. Additionally the camshaft had dropped in behind the mortar boxes requiring the team to manually raise the three tonne shaft up the hill by two Turfor hand winches, anchor it in place for the duration of the rebuild until required to be placed back on the battery. The stamper rods, followers and shoes were flown out to a nearby clearing to reduce the weight on the mortar boxes.

With the Lord Brassey battery having wooden kingposts all of the supporting structure had to be reconstructed. Only the top section of one kingpost remained intact. As this section had a number of fittings and bolts attached it was flown out along with all the other iron fittings recovered from the site e.g. nuts bolts, washers, tensioners, stamper rod guide blocks, camshaft pedestal blocks and caps, nearly two tonne of fittings were flown to the road end then taken to the workshop to be prepared for re-use.

At the Golden Lead battery all timber fitting was completed on site, however the Lord Brassey battery was not as straight forward as the height of the camshaft was not known plus the engineers and archaeologists drawings of the battery structure were not consistent. Both missed the kingpost back stays, nor had they found the end of the kingpost bearers at the back of the framework, probably due to this area being covered in rubble and building remains from the hillside above, also embedded in there was the camshaft and a water pipe. No historical photographs of the inside of the battery building have been located. Photographs from the

1970's were the earliest available, these were consulted and bolt positions measured after the foundation beams were dug out, this gave enough information to determine placement and size of the back braces, once the brace size was known additional timber was ordered. In the rebuild all but three of the original nuts and bolts were used. The four kingpost sets and berdan frame were fabricated in the Reefton workshop. All of the brace birds-mouth joints, cross sectional recessed faces and chamfered king post tops were completed by adze.

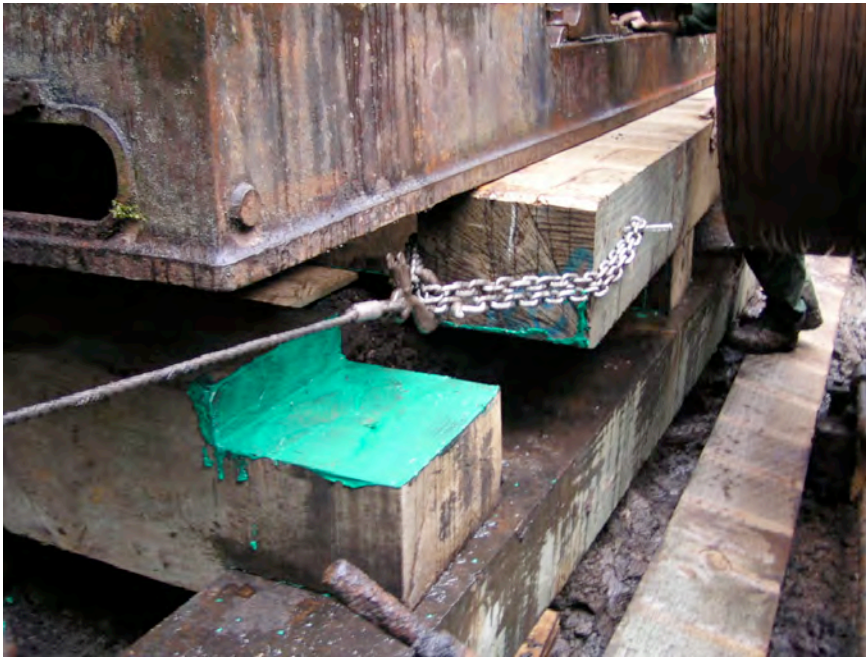
Figure 4: Big River sawmill engine foundation replacement, use of bridge spikes and chain with hand winch to slide beams into position. Note the Koppers CN Emulsion colour. 2006 (Jim Staton)

Simple items such as 250mm bridge spikes (large square timber nails) driven into a beam provide handles for pulling and positioning, leather gloves need to be worn. Also useful for

winching beams, put a chain through the spikes near the end of a beam and hook on the wire rope, an easy winching technique.

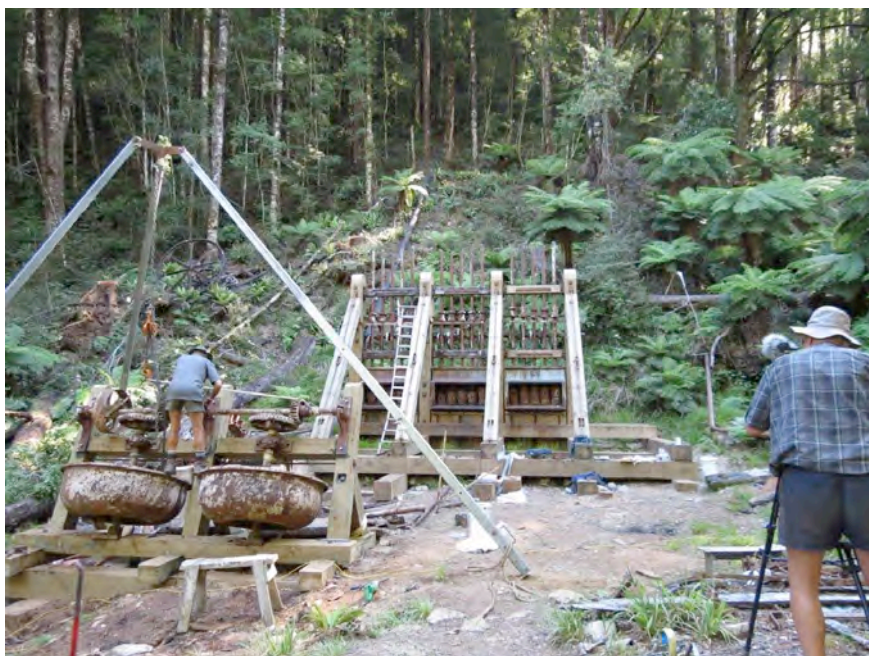
Figure 5: Lord Brassey battery, Jim Staton tightening the last nut, shear legs positioned above the berdans.

At the Lord Brassey battery site to lift the three heavier items a set of shear legs with a three tonne chain block attached was positioned over the item requiring lifting, they were the pelton wheel and two berdans. Shear legs are difficult to manoeuvre by hand, initial positioning was done by helicopter as the total weight of the legs exceeded the physical ability of the team, then 25mm hemp rope was used to shift each leg to get stability, any such heli-lift has to be factored into the helicopter flight programme.

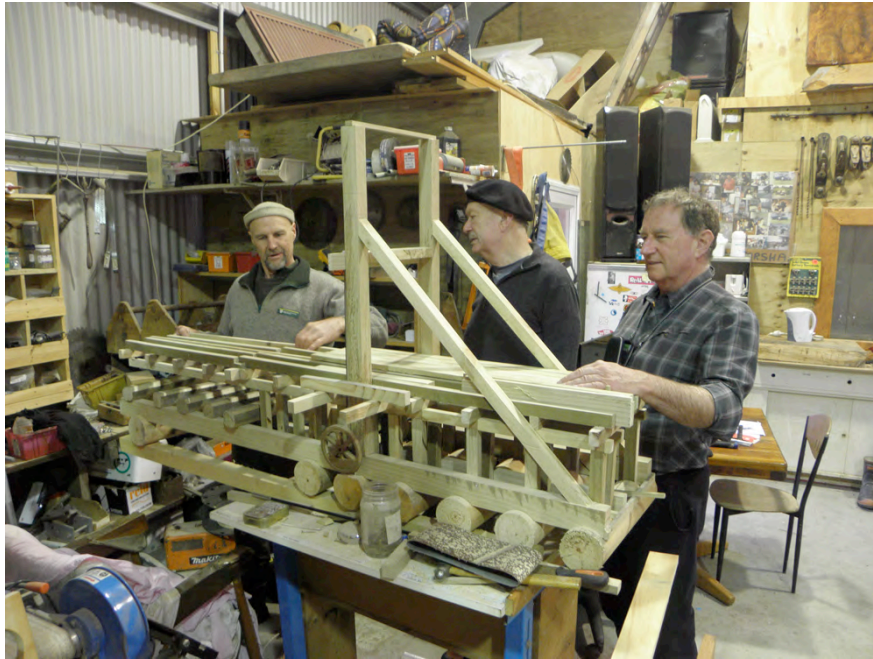
Figure 6: The next think big project, model of a full size kauri sawmill to be rebuilt in the Waitawheta Valley (Neville Ritchie)
