Desalination by captive-head washing: results of simple trials

David Young

DESALINATION BY CAPTIVE-HEAD WASHING: RESULTS OF SIMPLE TRIALS

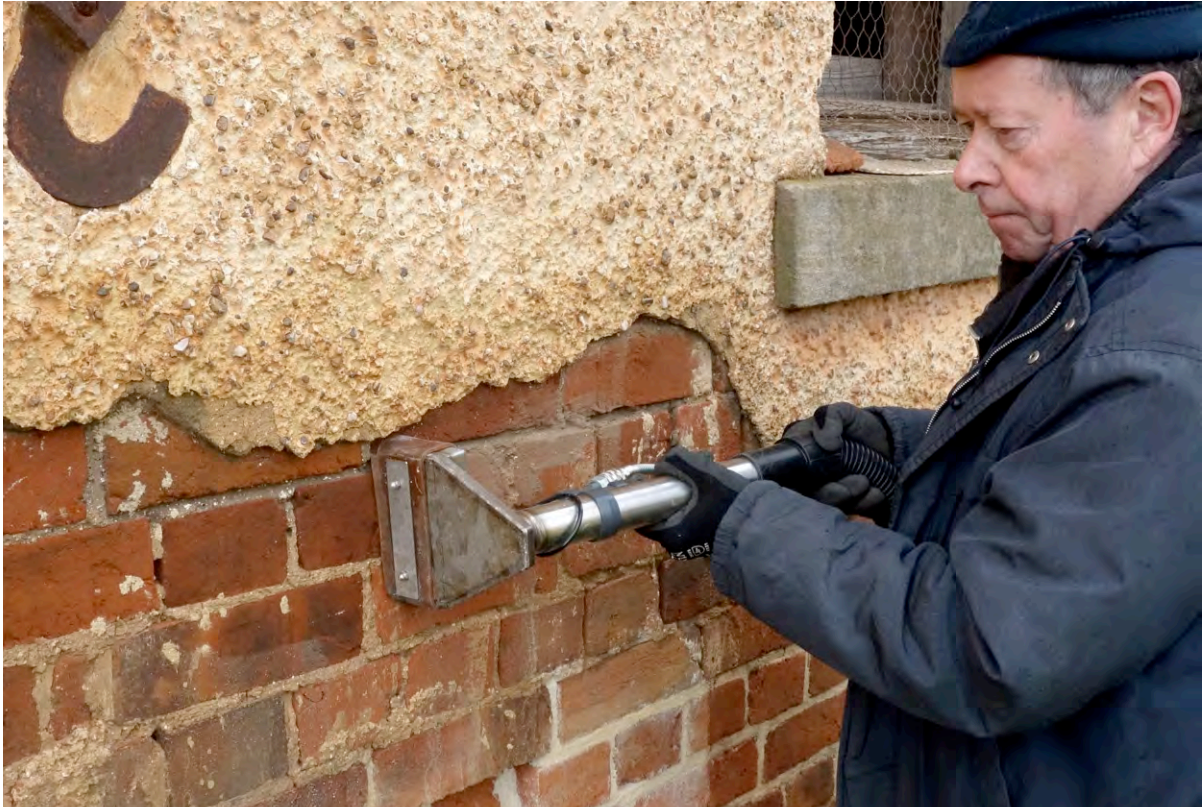
Figure 1 Captive-head washing system being used by Walter Heim to remove dust and dirt from brickwork prior to render repairs at Brickendon, Longford.

Captive-head washing is a system designed for cleaning dirt and grime from building façades in which the dirty wash water is captured by a wet vacuum cleaner, thus minimising clean-up and waste disposal issues. Figure 1 shows the head in use, cleaning dust and dirt from a brick wall prior to render repairs. The head contains a low pressure spray nozzle which is connected to a water supply. A flexible 'skirt' encloses the head and seals the unit against the wall surface so that the attached wet vacuum-cleaner recovers almost all of the wash water.

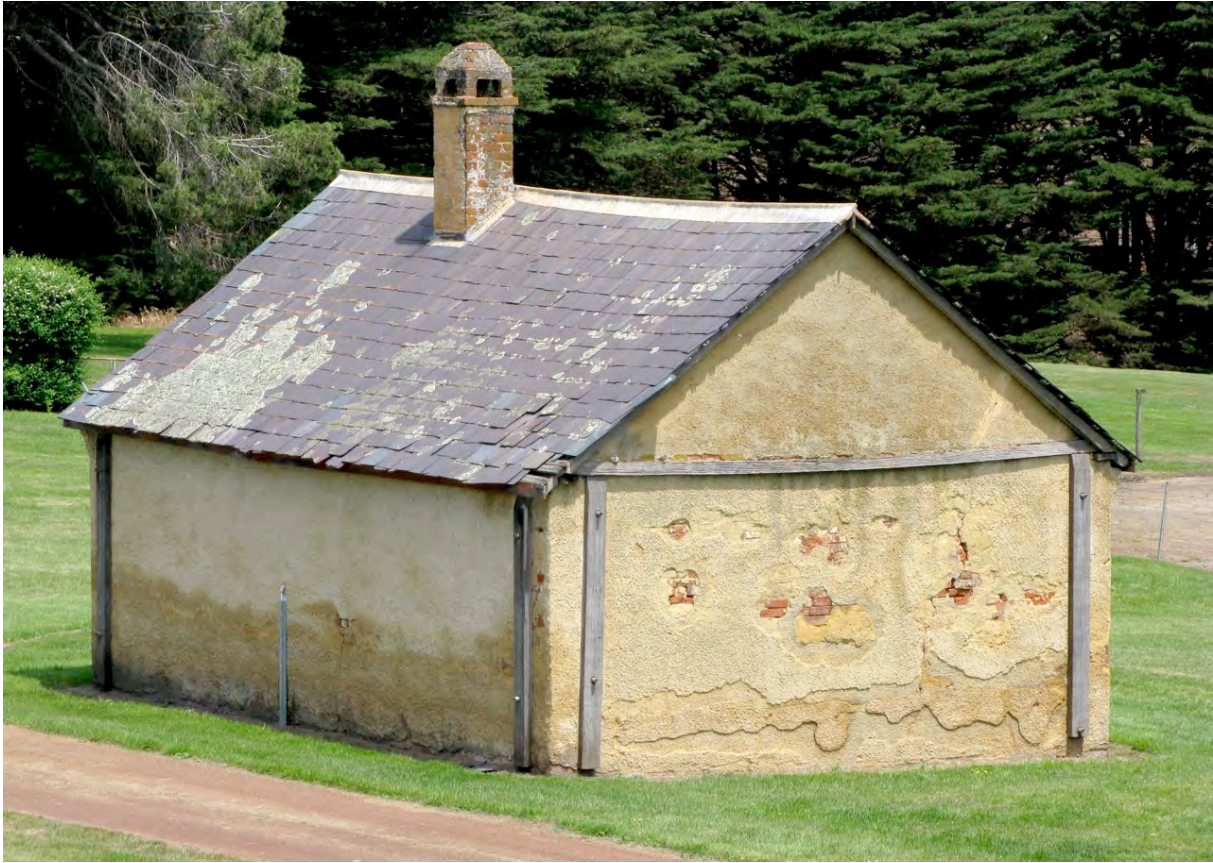
Figure 2 Woolmers Estate blacksmith's shop from the north. Failed roughcast rendering on the northwest wall (to the right) is allowing penetrating dampness to carry salts through the 350 mm brickwork to the interior (see Figure 3).

The 1820s blacksmith's shop on the Woolmers estate (Figure 2) is a brick building with a roughcast-rendered exterior and limewash finishes on the interior. The 350 mm thick brickwork suffers from rising and penetrating dampness which carry salts through the walls to the interior surfaces. The northwest wall is the worst-affected, the low-fired bricks are severely decayed by salt attack across much of the interior surface (Figure 3).

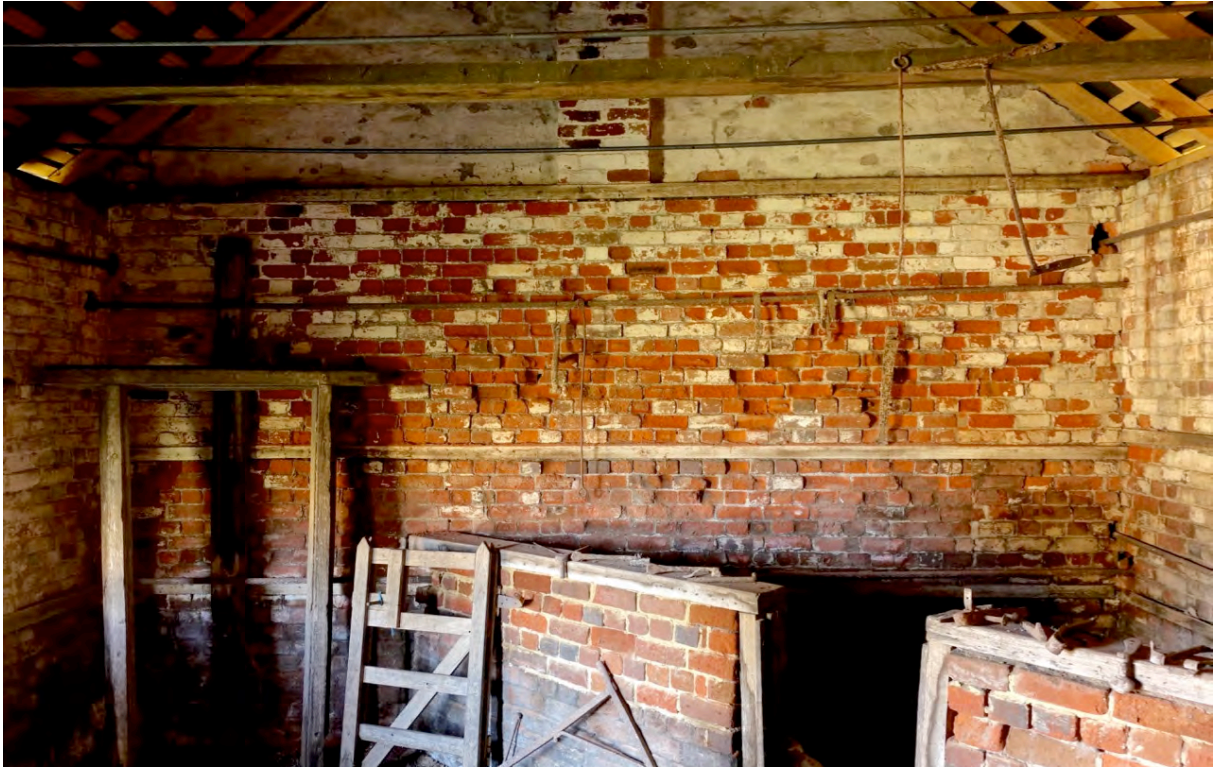
Figure 3 Interior of northwest wall showing extensive decay of low-fired bricks due to salt attack. 8.8 m² of the wall was treated with two passes of captive-head washing.

Trials were conducted on the interior of the northwest wall (Figure 3) and covered an area of 8.8 square metres. The captive-head unit was drawn slowly across the surface to allow time for the wash water to dissolve salt lying on and in the surface of the brickwork. Two separate passes were made across the whole surface of the wall.
