Trials of biocide cleaning agents on Sydney sandstone

Elisha Long & David Young

TRIALS OF BIOCIDES CLEANING AGENTS ON SYDNEY SANDSTONE

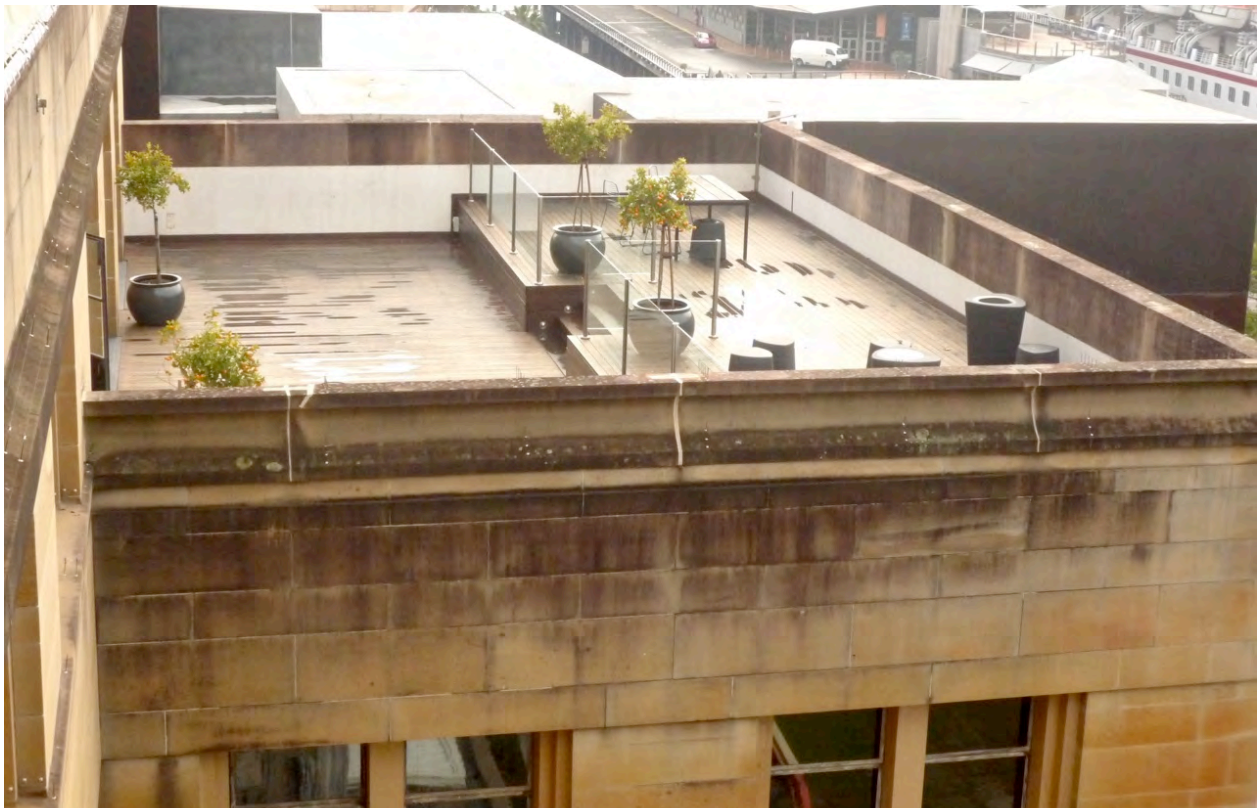
Figure 1 View looking north over the northern balcony of the Museum of Contemporary Art building. Trials were conducted on the inside faces of the very large parapet stones to the north, east and south walls of the balcony.

The trials were applied to the inside of the parapet walls of a roof-top balcony on the north-east corner of the building (Figure 1). The choice was driven by the presence of significant levels of biological growth which were easily accessible for both application and monitoring, and which would not affect the outwards appearance of the building for the period that the trials were underway. The trials were applied to three parapet walls so that the effect of different orientations could be observed.

Table showing testing scheme of biocides, application methods and surface conditions. The complete scheme was applied to each of the three parapet walls of the balcony (Figure 1).

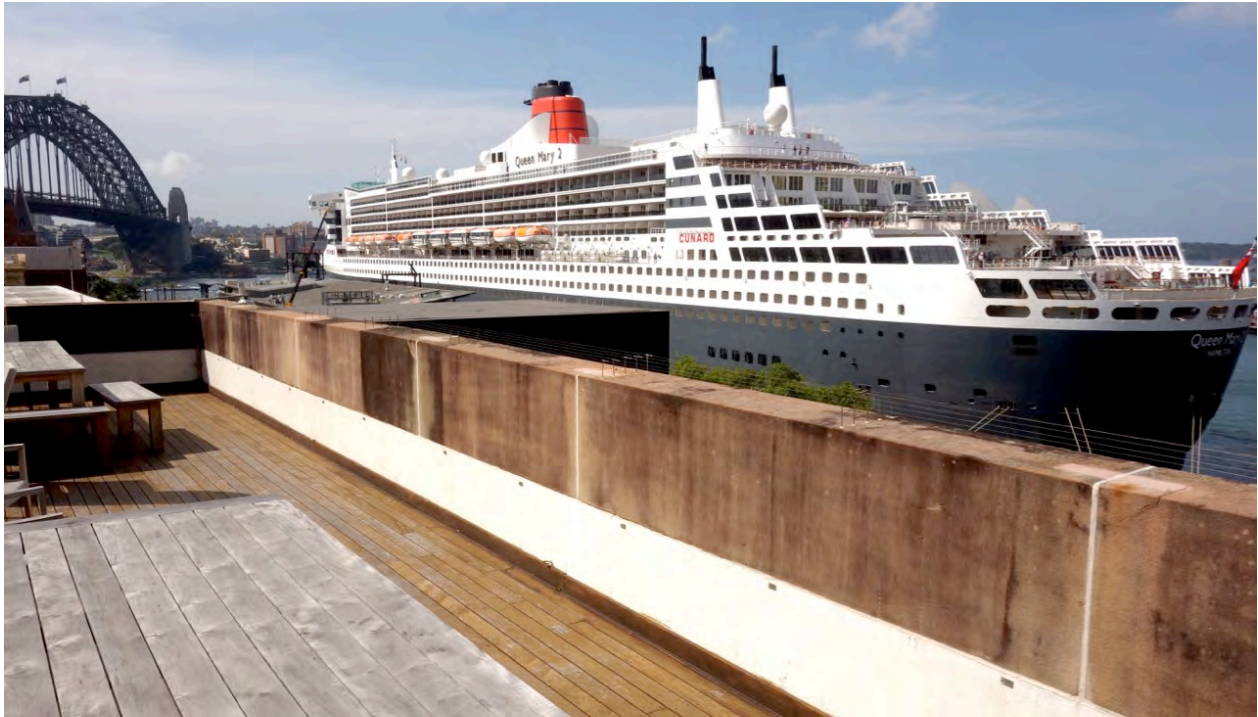
Figure 2 The eastern wall of the balcony, 23 months after treatment. The dark area left of centre is the untreated control panel; to its left are panels treated by poultice application of biocide. Note the wide zones around the mortar joints showing a biocidal effect, and the evidence of previous cleaning in the form of horizontal bands from pressure-washing.

- orientation of the trial panels, which face north, west and south, leading to different micro-environmental conditions for the biological growths, and different photographic recording conditions, both making comparison between walls difficult;
- the influence of mortar joints — alkalinity from the mortars has had a biocidal effect which extends some distance from the joints (Figure 2);

- run-off from the horizontal top of the parapet which intensifies growths in some locations, and may be contributing to regrowth;
- previous cleaning — now visible as horizontal bands from pressure-washing (Figure 2);
- other treatments — which have left various marks on the stone surfaces, some of which have become apparent only after the cleaning trials have removed much of the biofilm;
- location of trial panels close the walls of the main building — which has resulted in less-effective cleaning due to additional water run-off and splash from the wall surfaces;
- untreated control panels have continued to accumulate biological growths, increasing the contrast between treated and untreated panels, and so complicating assessment of the degree of cleaning achieved (Figure 5).
