Architectural Wooden Preservation in Japan: Gokoku-ji Temple and Intangible Skills

Gekko-den Pavilion at Gokoku-ji Temple

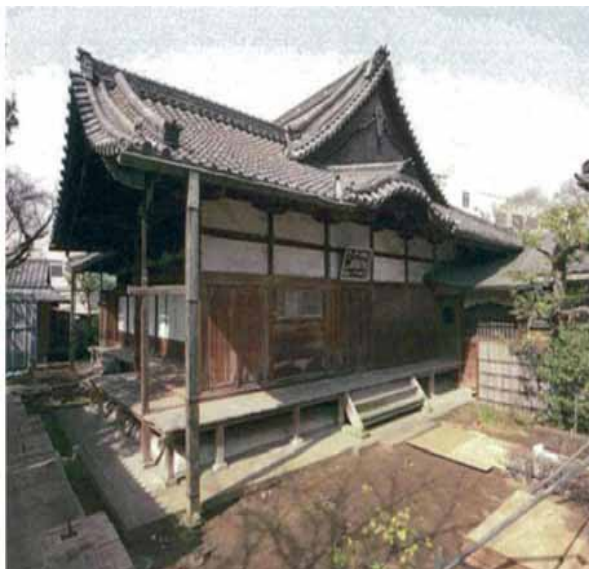
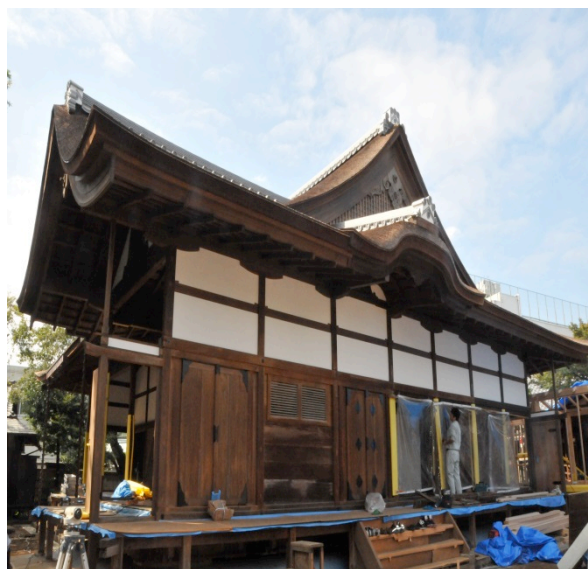
Fig.1.1. Archival photographic illustration prior to preservation commencement [courtesy of Agency for Cultural Affairs ACA] **Fig.1.2** Photographic illustration in the final months of preservation, 30th September 2013 [photograph by author].

Preservation of Gekko-den began in November 2008 and continued until October 2013. The decision for full dismantlement of the structure was based upon an extensive inspection of the structure which revealed numerous members had lost structural integrity. During the 80 years since the move of Gekko-den to its current site structural members have begun to show obvious weakening. Depression of the ground under the flooring system was extensive and deformation and sinking of the structure had become significant.² It was due to these contributing factors, the decision for full dismantlement was made.

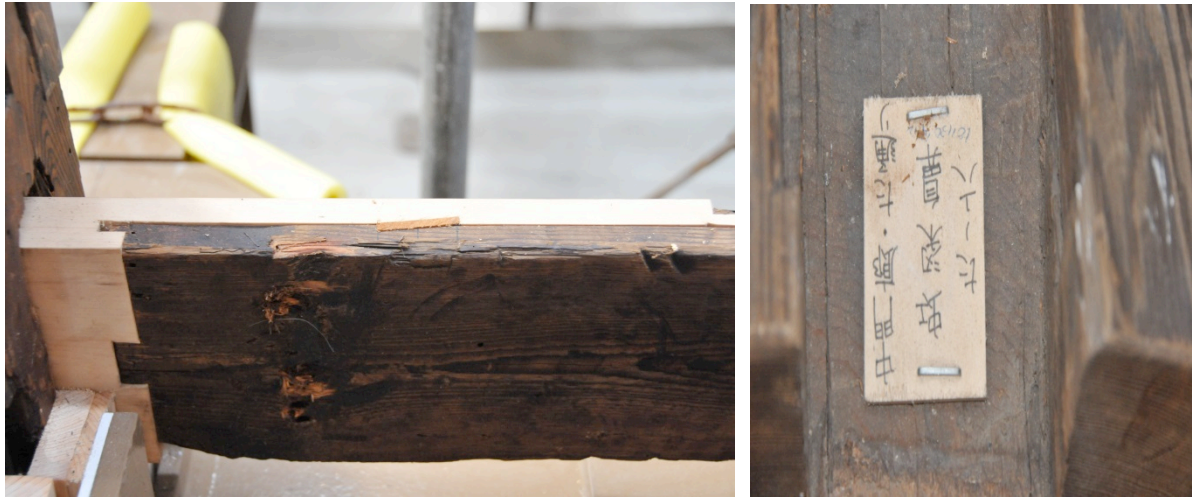
Fig 2.1 Photograph depicts original wood spliced with fresh Hinoki wood at post base joint. Traceology reveals traditional hand tools such as the Adze which is used to skim off the outer molecular surface of the wood, thus creating a barrier, providing superior resistance to moisture penetration. [photography by author]. **Fig 2.2** Number plates are attached to each wooden member [photography by author].

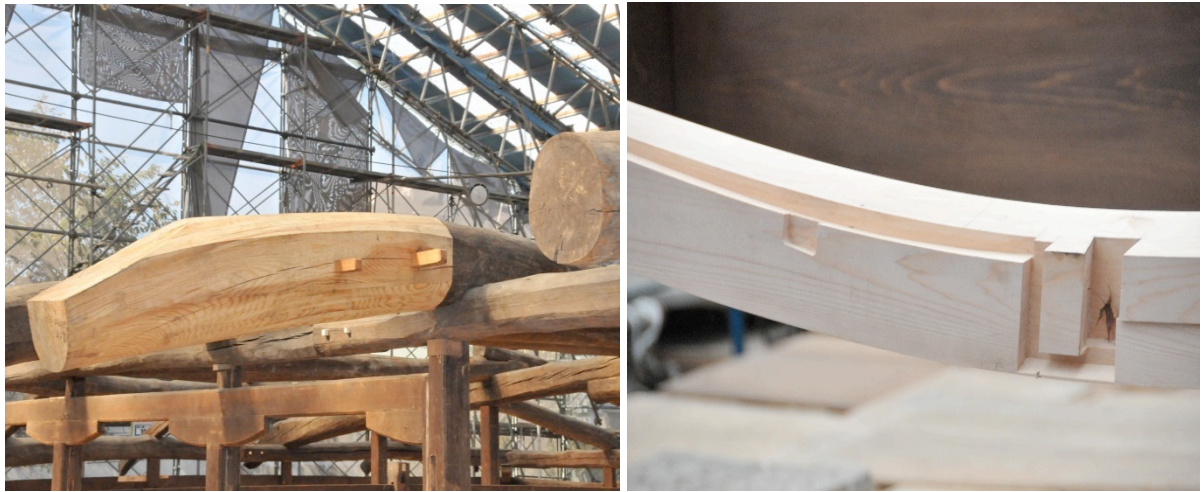
Fig 3.1. Wooden members of larger dimensions need minimal replacement. Traditional tools are used to seal the surface of the wood, ensuring resistance to moisture penetration. **Fig 3.2.** Curves are achieved without the bending of wood, figure depicts detail of carpentry.

Even though the main structural components are relatively large, dimensional tolerances are very fine, particularly in the case of surfaces that will remain visible. Allowances are made for wood movement, such as expansions and contractions due to changes in temperature and humidity in Japan's temperate climate, and also gradual deflections under constant loadings.

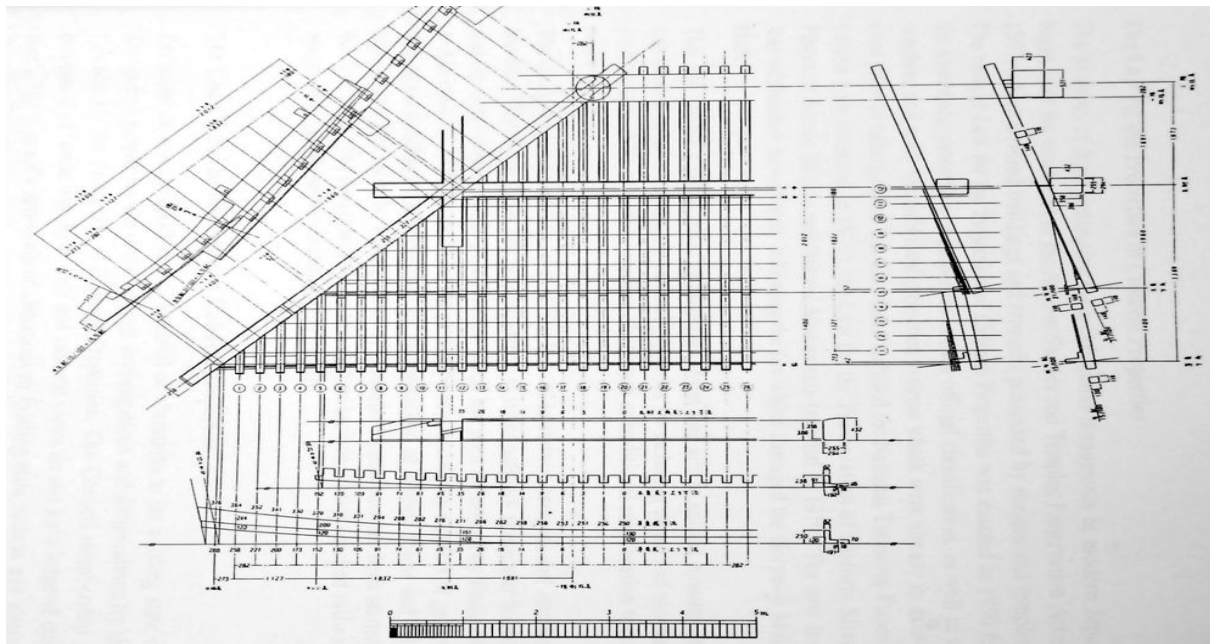
Fig. 4. Kiku is a mathematical/geometrical calculation system highly developed by the latter half of the 18th century [Courtesy of ACA].

It is imperative that all respective wooden members fit exactly into positions indicated in the drawings, for flush jointing connections. Accordingly it is necessary that ink lines are drawn onto the wood's surface are perfect. *Kikujutsu* (stereometry) enables master carpenters to draw only with the help of an L-shaped square. The inked timbers are all cut and planned
