Evolution of Stone Cladding Technology: monitoring and intervention techniques for stabilization

(Un) Loved Modern Conference 2009 Sydney, Australia

Kyle C. Normandin and Michael J. Scheffler Wiss, Janney, Elstner Associates, Inc.

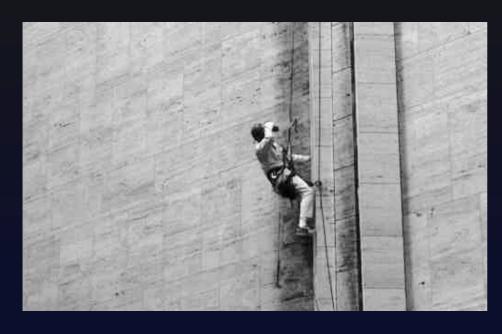
Lincoln Center for the Performing Arts -New York State Theater, Industrial Rope Access during "Close-Up" Travertine Inspection

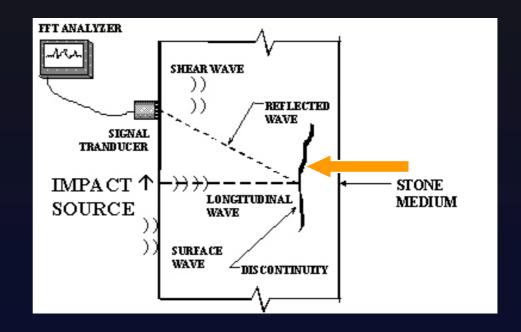
Diagram of Impact Echo Instrumentation: *Deficiencies that occur on the backside of a panel can be detected with Impact Echo testing.*

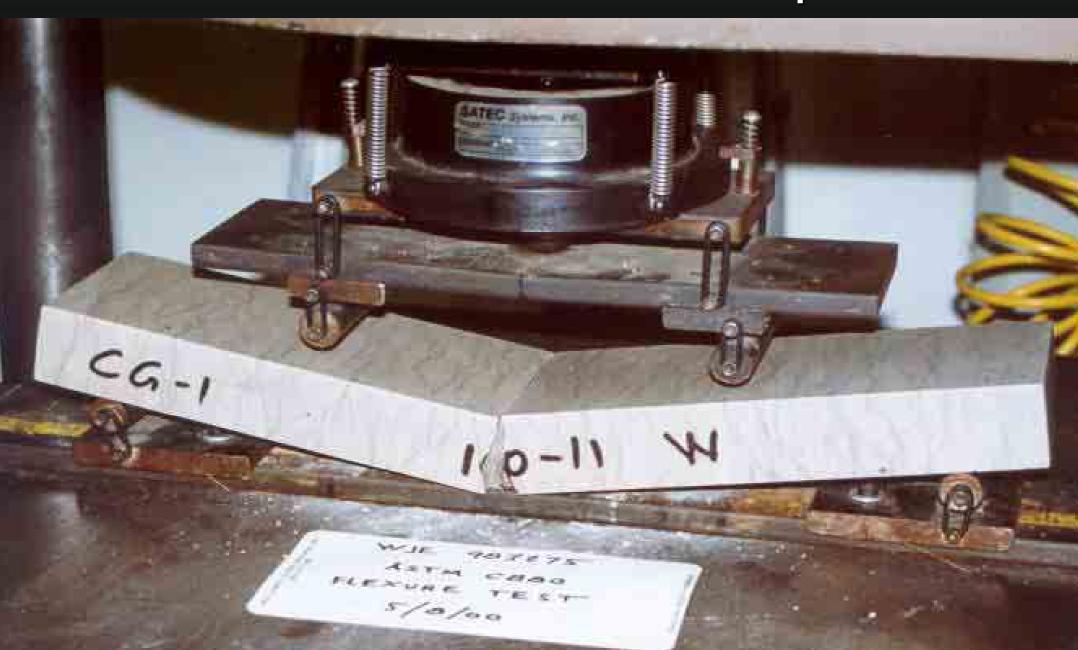
ASTM C880 flexural test on marble specimen
