# SOLOMON R. GUGGENHEIM MUSEUM

## EXTERIOR RESTORATION AND BUILDING ENHANCEMENT

Pamela Jerome, AIA

WASA/Studio A

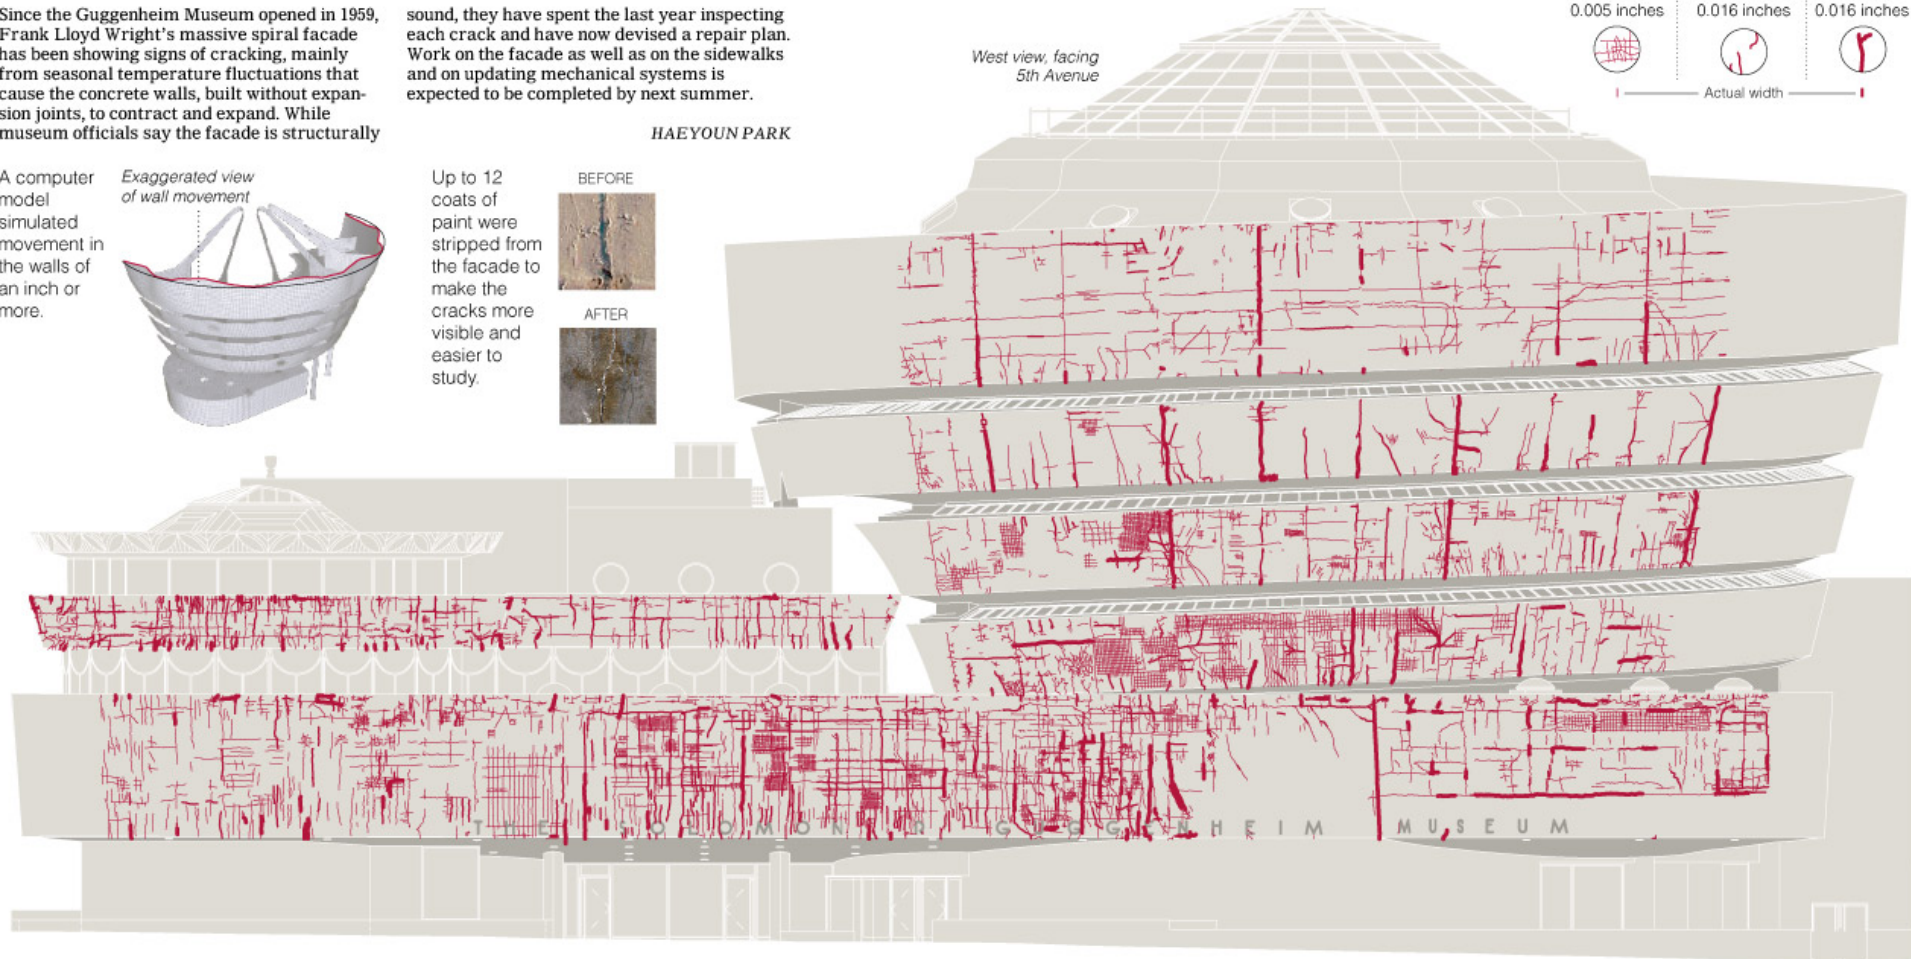
West view, facing 5th Avenue

Up to 12 coats of paint were stripped from the facade to make the cracks more visible and easier to study.
