Old Parliament House, Adelaide –

The practicality of the Burra Charter process

Old Parliament House, Adelaide – the practicality of the Burra Charter process

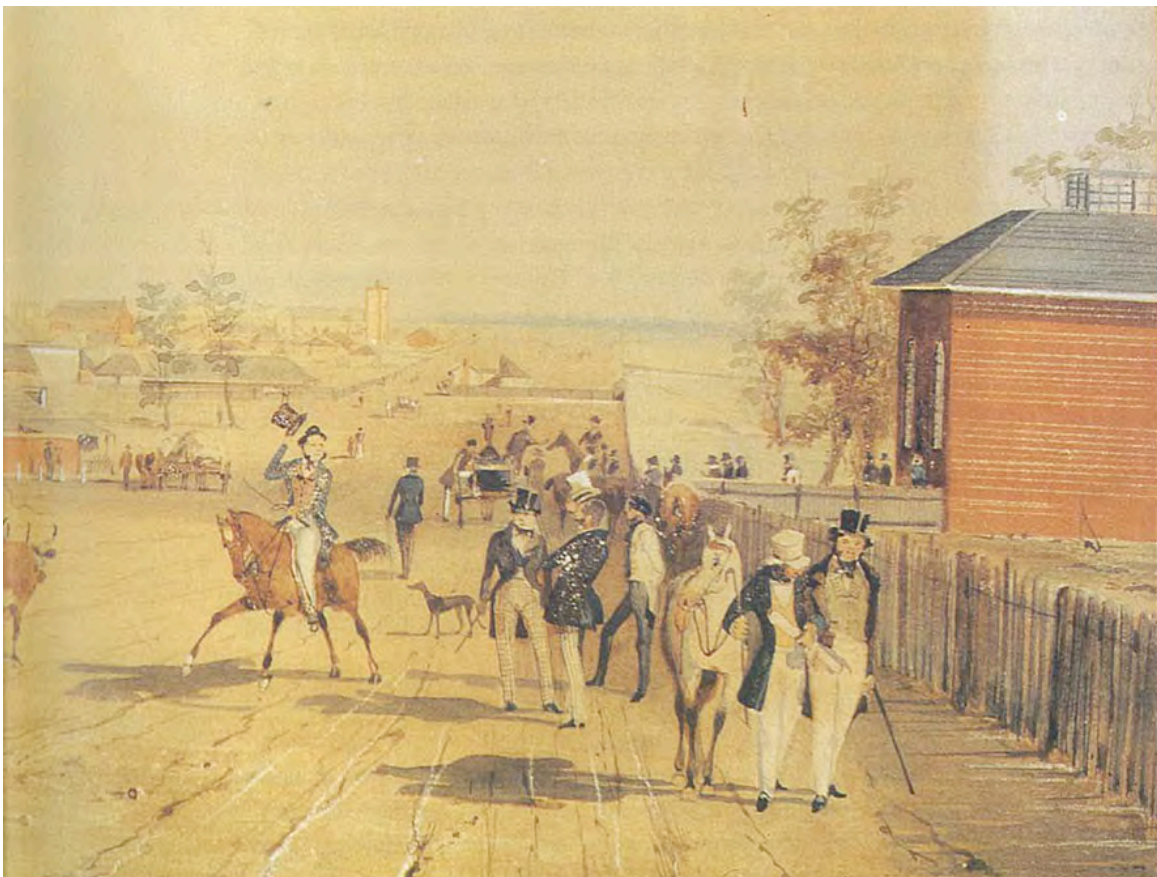
Fig.1 – North Terrace 1845, looking west showing the first Council Chamber on the right (*ST Gill, Art Gallery of South Australia, reproduced in Stretton p.15*)

The building originated with the decision of Governor Captain George Grey, to spend £200 on constructing a meeting place for the first Legislative Council in 1843 (**Fig.1**).¹ Until this time the government had consisted of the Governor and his senior public servants, whom met in-camera in the sitting room at Government House (Coombe 2009:226). The new body, consisting of the Governor, three senior public servants and four appointed private citizens, was to meet in public (Pike 1967:247). Probably it was Grey's steadfast pursuit of his policy of economic restraint that led him to the fateful decision to make the new meeting place an addition to the existing Resident

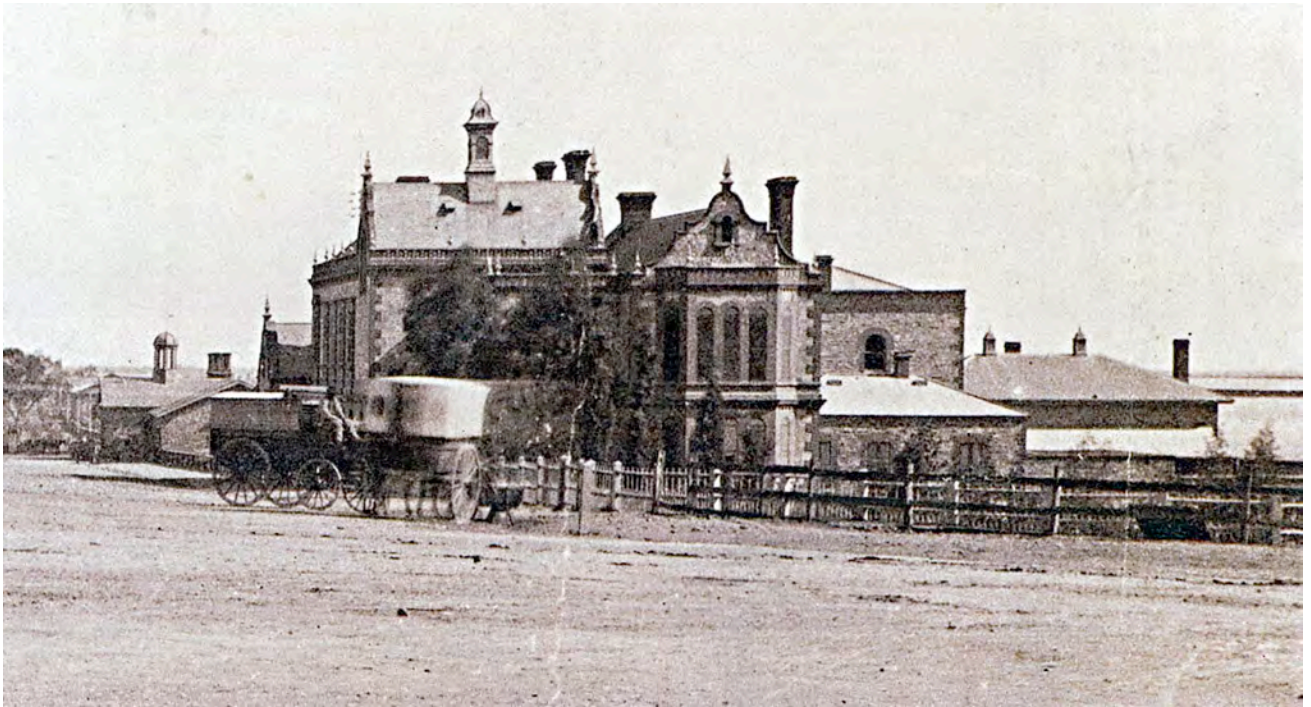
Fig.2 – View of Old Parliament House from the east, c1868 showing the growing collection of buildings, with the 1854-1855 section facing the street, the 1865 altered Legislative Council Chamber behind the associated single storey Smoking Room and the 1861 Refreshment Room on the right (*B1867, State Library of South Australia*)

justification that the building was temporary was resulting in a confusing structure, one where ‘*a definite plan of what it really is becomes impossible to obtain.*’⁴ The building’s location was hated, while the structure itself was seen as an embarrassment, it was compared to a London poor house, while one member thought that at least they would be safe should a foreign power invade, as they would simply bypass the building assuming that it served some minor function.⁵ The resulting complicated and confusing building is however the embodiment of the complex, turbulent and evolving politics of the Parliament during this period (**Fig.2**).

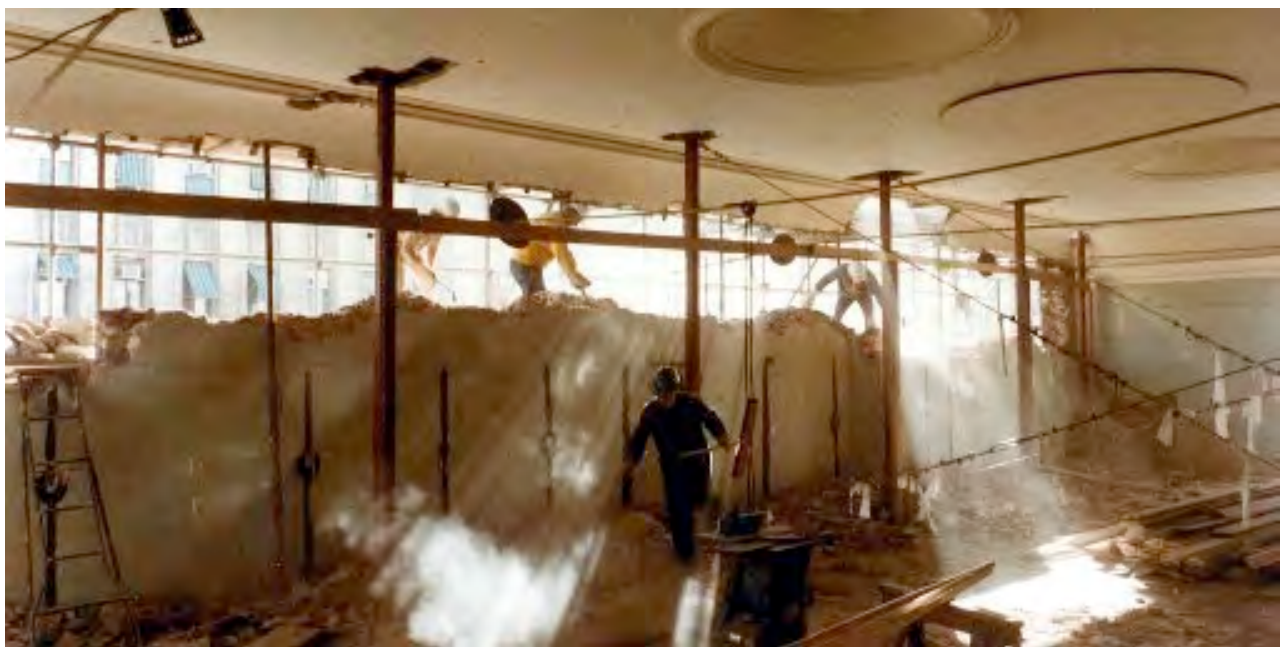
Fig.3 – Demolition in progress on the upper west wall of the former Legislative Council Chamber c1978, showing the extent of intervention carried out at the time (*History SA*)

debated and won consent in 1894, while the first draft of the Federal Constitution was prepared here as part of the first Australian Federal Convention in 1897. With the eventual completion of Parliament House in 1939, Old Parliament House was then destined for demolition but was saved by the advent of World War II.⁶ Post war shortages saw it used for various minor government purposes until its historical importance came to be acknowledged. It was subsequently conserved and reconstructed in the late 1970's to create a new museum of political history. This phase had not been researched previously. Of particular interest was a large collection of images which had been taken by the staff of the Constitutional Museum during the construction phase, these helping to confirm the nature and extent of some of those works and the degree of intervention which had taken place at the time (**Fig.3**).

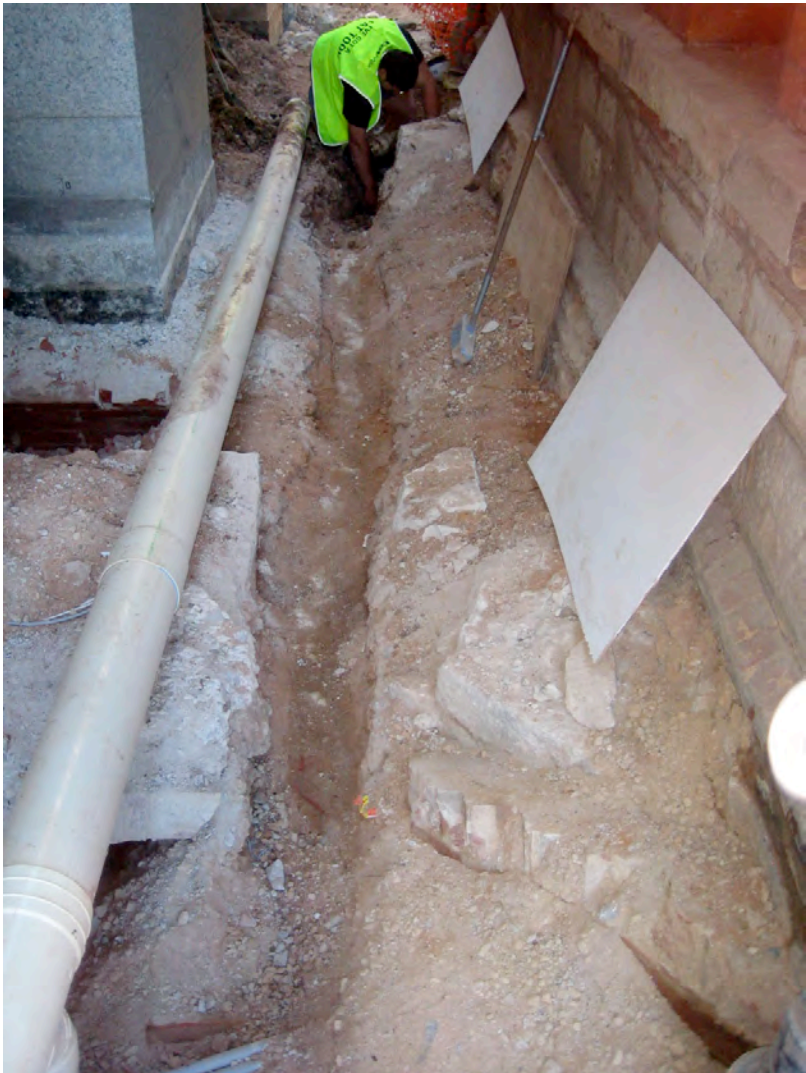
Fig.4 – Service excavations revealed the footings of the former east bay window which required diversion of the services (Swanbury Penglase 2012)

removed in the early 1970s and the bay window to the east elevation removed in the 1880s for the construction of Parliament House (**Fig.4**). The discovery of these caused various services, including a major stormwater line, to be redirected to prevent further damage of those remains.

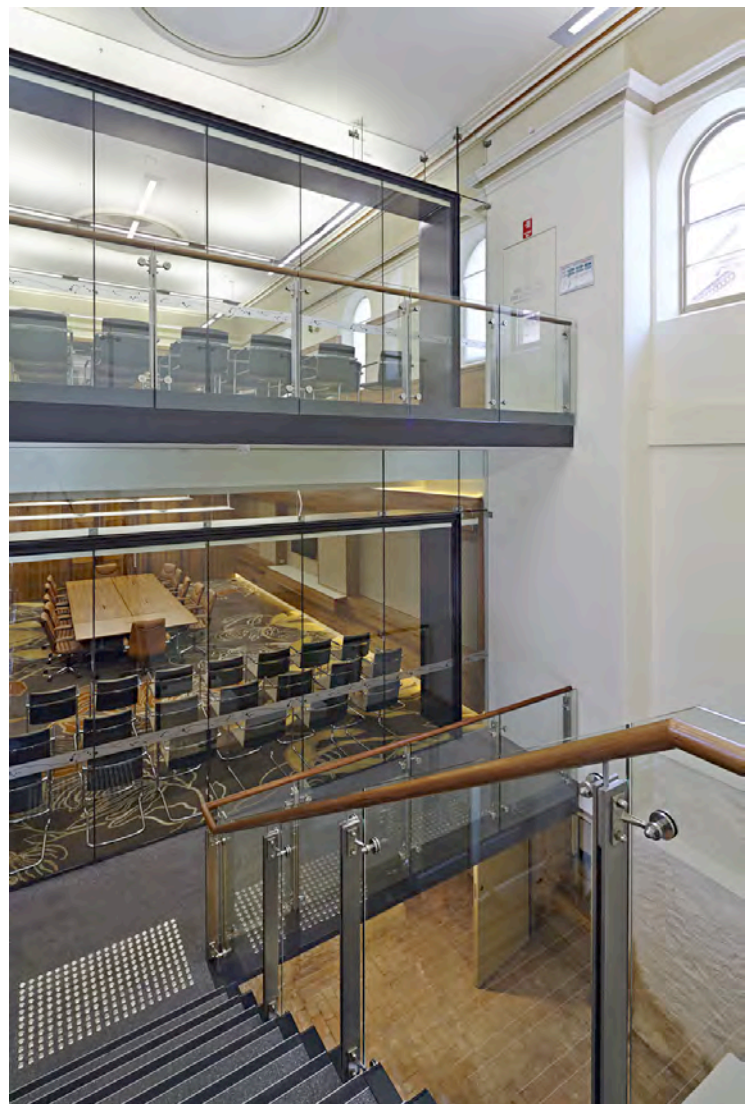
Fig.5 – Former Legislative Council Chamber on completion of the works showing the two new committee rooms (David Russell 2014)

charcoal thermal insulation to remain in place above despite the initial reaction to remove such a potential flammable material. Our chosen detailing method to distinguish our interventions did prove difficult in this space, as the walls proved to be considerably out of square, and erecting the new steel and glass which formed the division between the meeting rooms and the circulation and interpretation void was a constructional challenge (**Fig.5**). Panelling was introduced within the meeting spaces due primarily to help achieve the high acoustic requirements, but this also helped to conceal the unsightly columns needed to support the 1962 concrete floor slab which divided the space, as well as the new services, particularly the air conditioning system. This also co-opted the original ceiling vents which retain their original roof mounted Boyle ventilators.
