## **TARPS AND TILES AND THE FATE OF SLATE:**

### ***THE HERITAGE IMPACT OF THE 1999 SYDNEY HAIL STORM***

#### ***ON THE CITY OF SYDNEY***

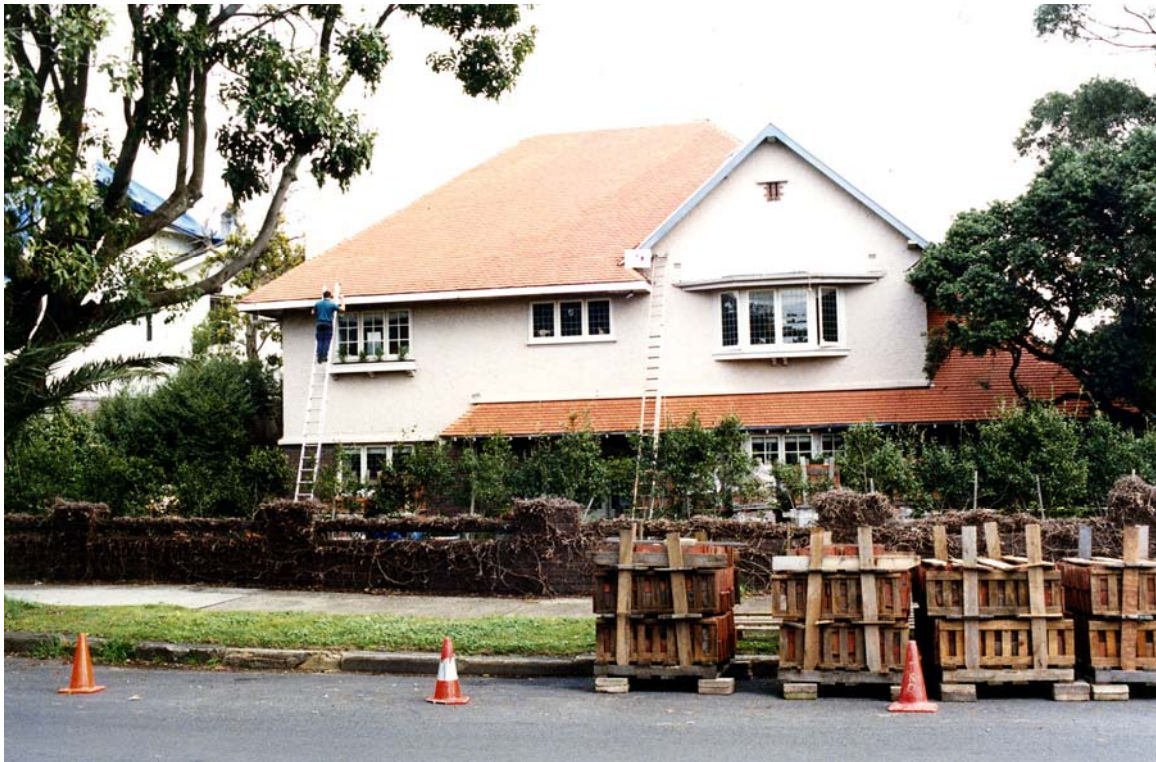
6 Martin Road, Centennial Park  
(December 1999 photo from Centennial Park Conservation Areas Study)

In fact, many buildings still remained with tarps on their roofs, waiting for slate, at the end of 1999, particularly in the Centennial Park area. A few buildings, such as Ashton<sup>4</sup>, remained for years with tarps on their roofs.

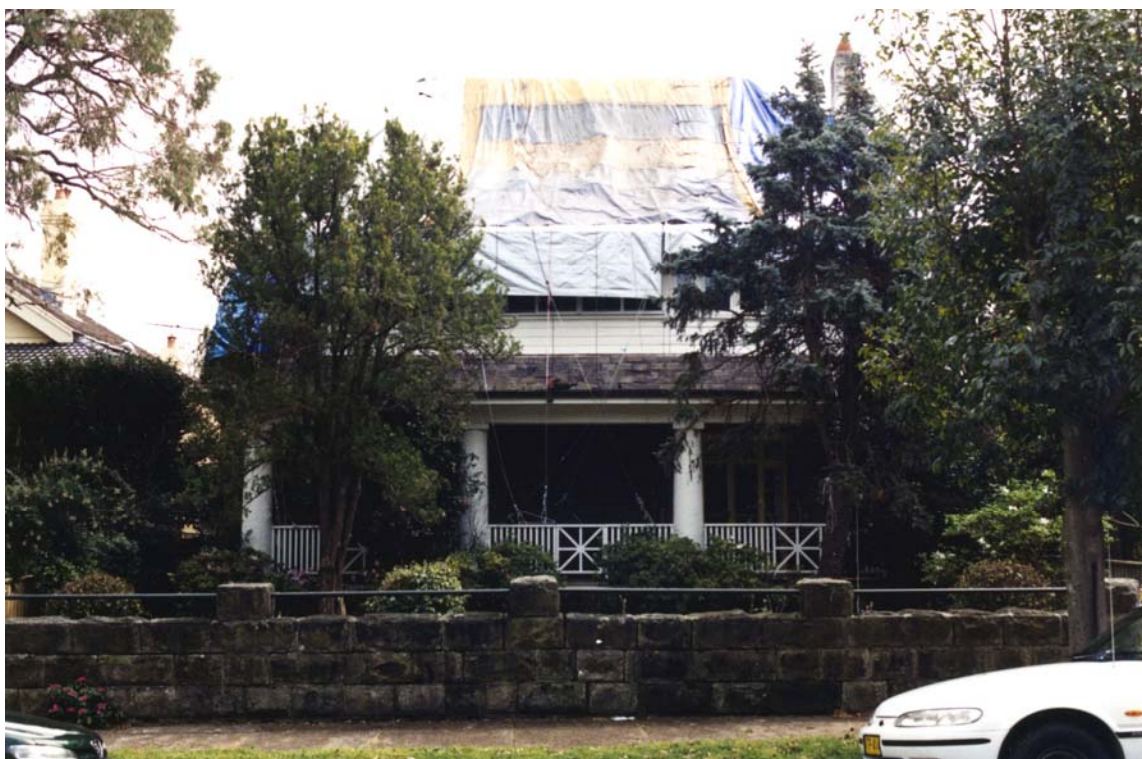
No. 8 Martin Road, Centennial Park  
(December 1999 photo from Centennial Park Conservation Areas Study)

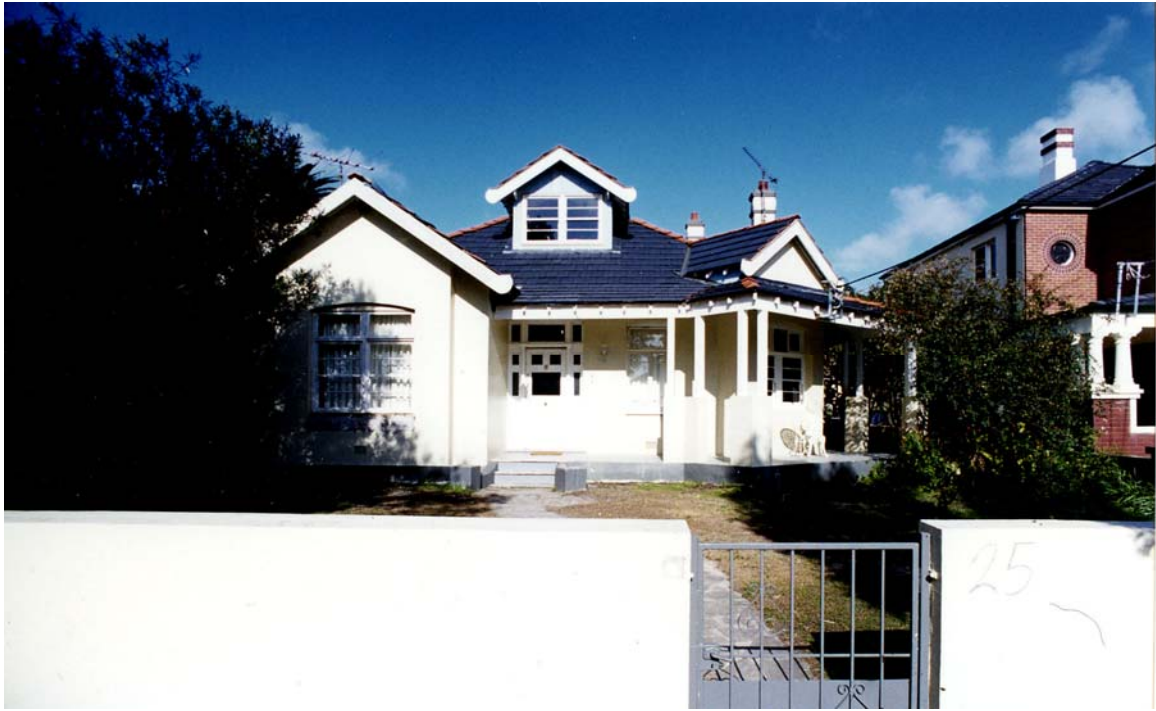
**25 Robertson Road, Centennial Park  
(1999 Photo from Centennial Park Conservation Areas Study)**

In December 1999 many roofs in the Centennial Park Conservation Areas remained to be repaired. Many of these presumably fully insured homeowners, in one of the wealthiest areas of Sydney, were still waiting for Penhryn slate from Wales and the availability of slate roof repairers.
